Nyrstar Hobart Triennial Public Environment Report 2019 – 2021

VERSION 2: SUBMITTED 13 MAY 2022

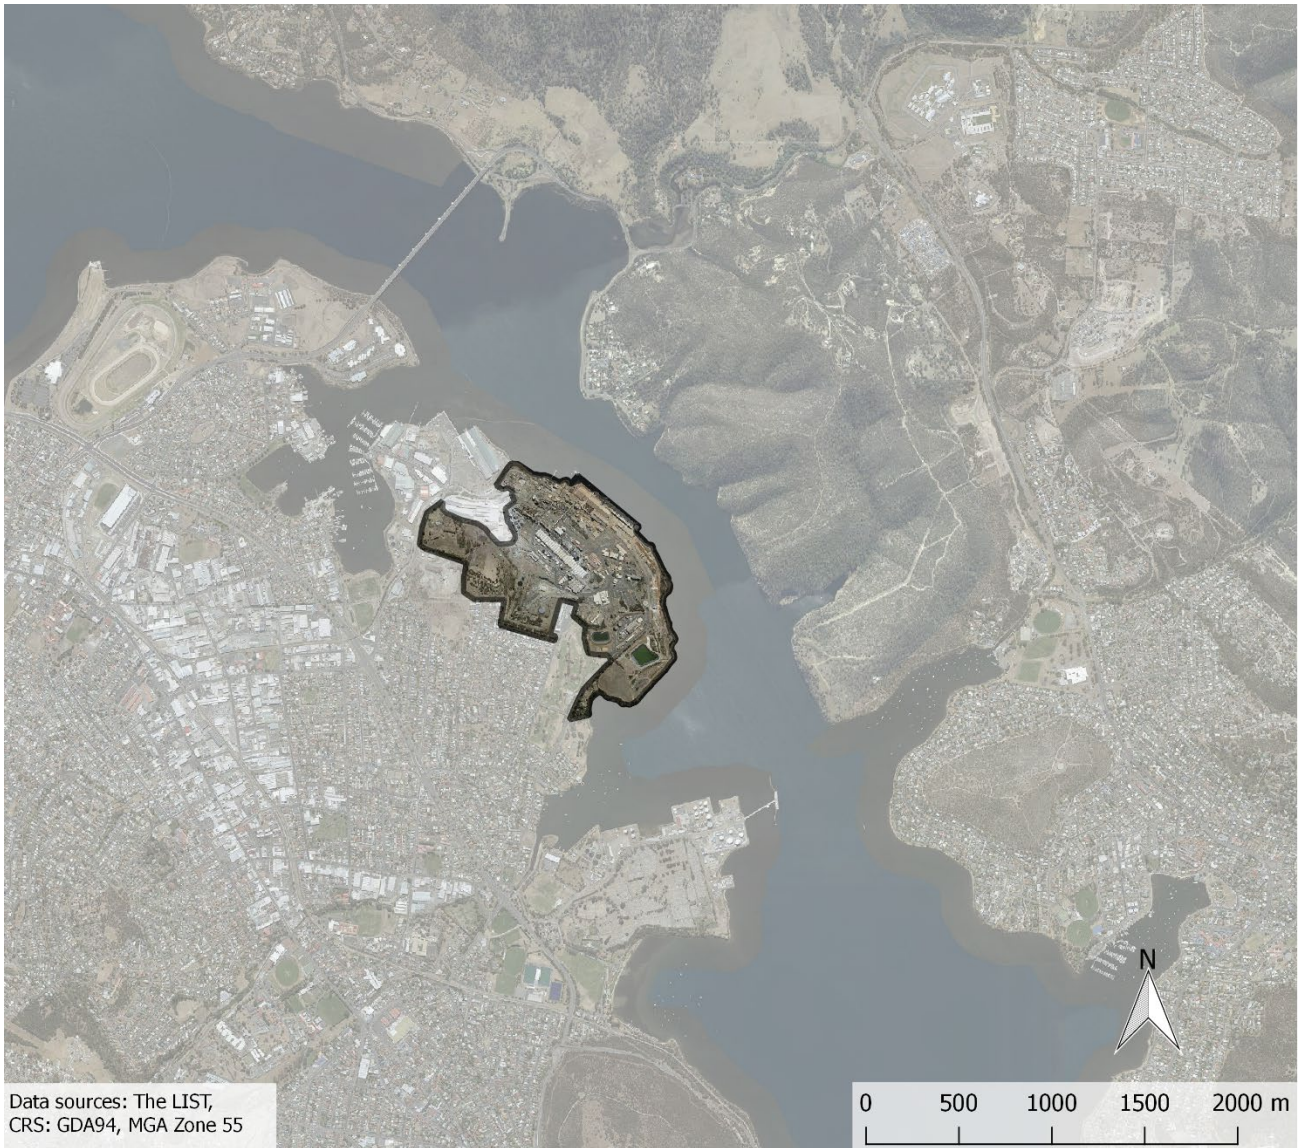
Figure 2-1 Nyrstar Hobart operational site location

The smelter is partially surrounded by a range of land uses, including General Residential, General Industrial, Utilities, Recreation, Open Space, Port and Marine, and Environmental Living. The NH operational site is shown in Figure 2.1, with the Planning Scheme information for NH and surrounding areas shown in Figure 2.2.

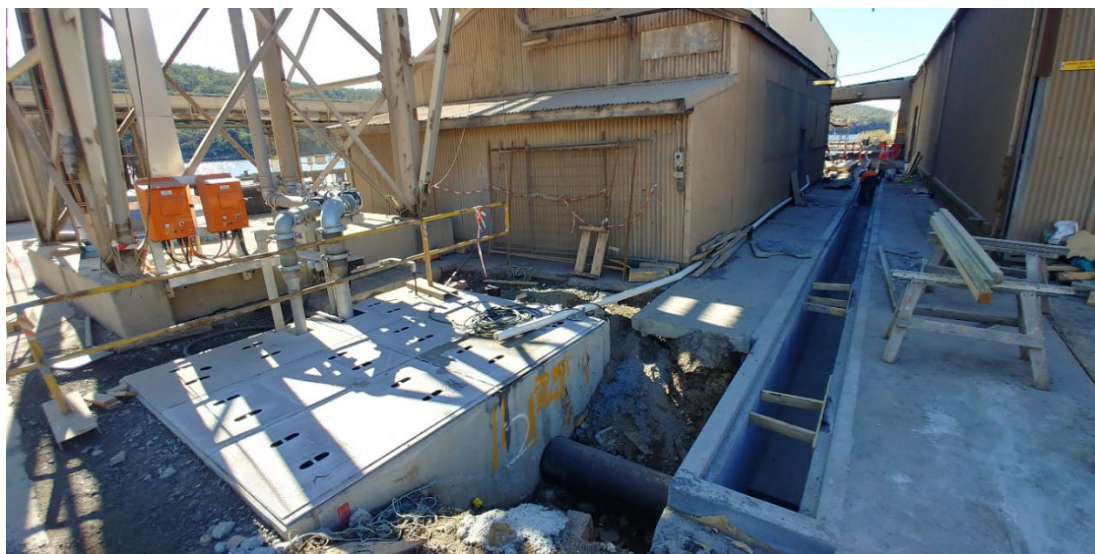
In March 2020, NH completed the final phase of the site stormwater collection system. Drains, pipes and pumps were installed in and around the wharf apron to capture stormwater from this section of the site. The NH site is now a fully closed circuit stormwater system, with all stormwater being captured on the site and directed to the on-site effluent treatment facility for treatment prior to discharge into the Derwent estuary.

Figure 2-8 Image of one of the stormwater pits, and drains installed at the Wharf

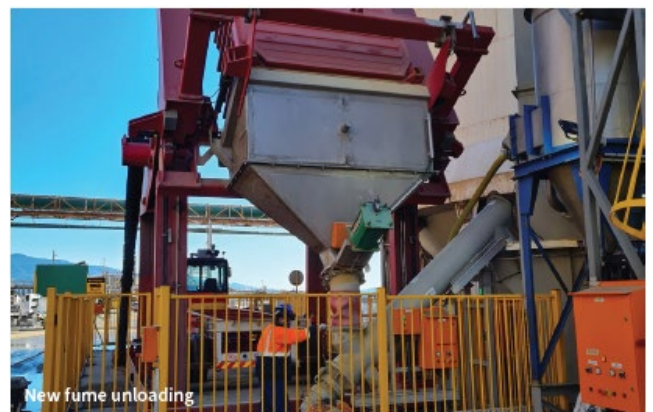
- Construction and commissioning of a new zinc oxide unloading facility. The facility enables zinc oxide to be received at the site in 20 foot shipping containers, rather than single use bulka bags. The new containers are shipped from Port Pirie, then they're trucked from the wharf to the new unloading facility. The containers are backed in, connected to the unloader then lifted and tilted before being conveyed into the storage silo – all dust free. The storage silo allows for direct, automated and continuous feed of zinc oxide fume into Leach; improving zinc recovery. The reduction in waste to landfill is a significant environmental benefit from this project. A purpose built baghouse has been installed with a continuous emission monitor for assessment of particulates in the emission stream.

Figure 2-9 Images of the new zinc oxide unloading facility

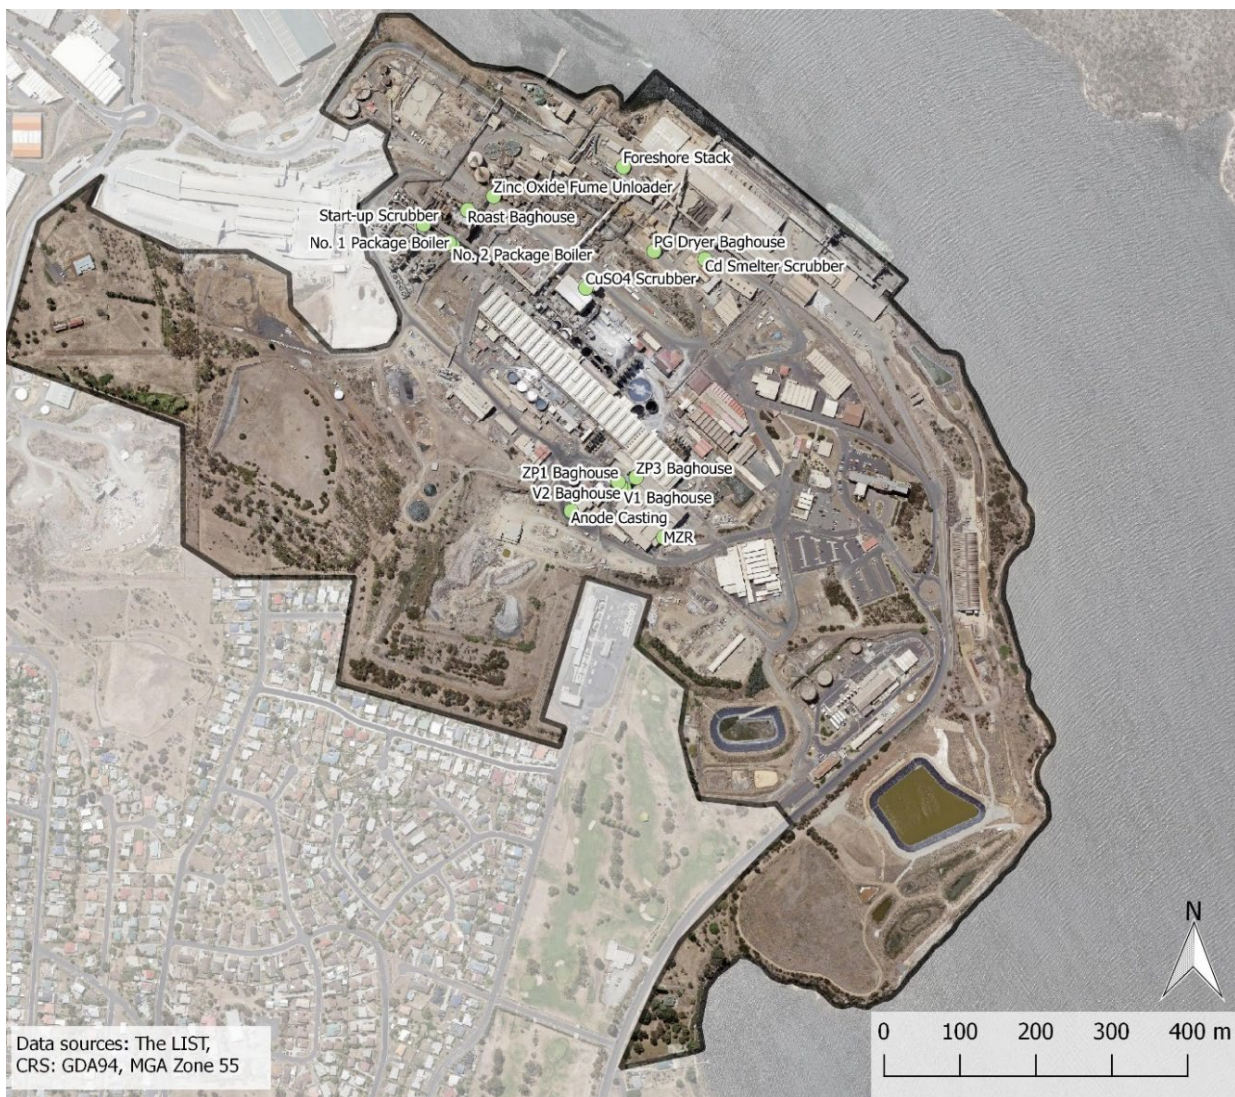
Figure 4-1 Locations of monitored exhaust points

- Two new package boilers, each with an associated stack were installed to replace the two old boilers in the Roast Department and,
- A zinc oxide fume unloader was installed with an associated baghouse and stack.

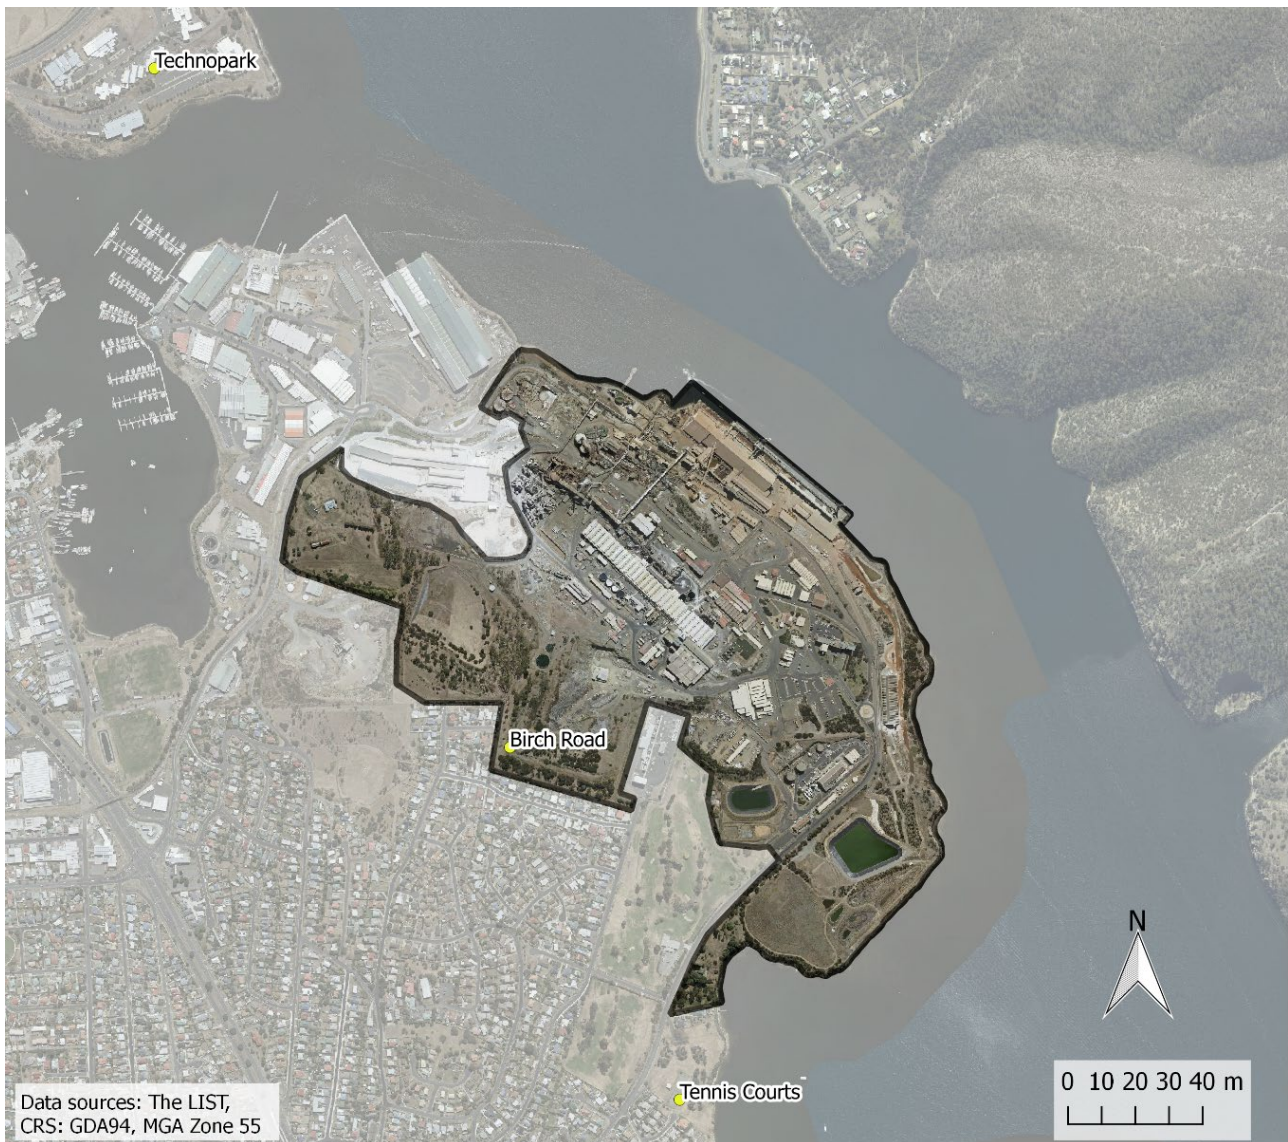
Ambient SO₂ concentrations are monitored using Teledyne API 100E and Thermo Fisher 43i analysers, certified to be compliant with recognised international standards for performance. SO₂ is measured continuously and five minute average concentration results are sent via telemetry to NH databases.

Figure 4-3 Community SO₂ monitor locations

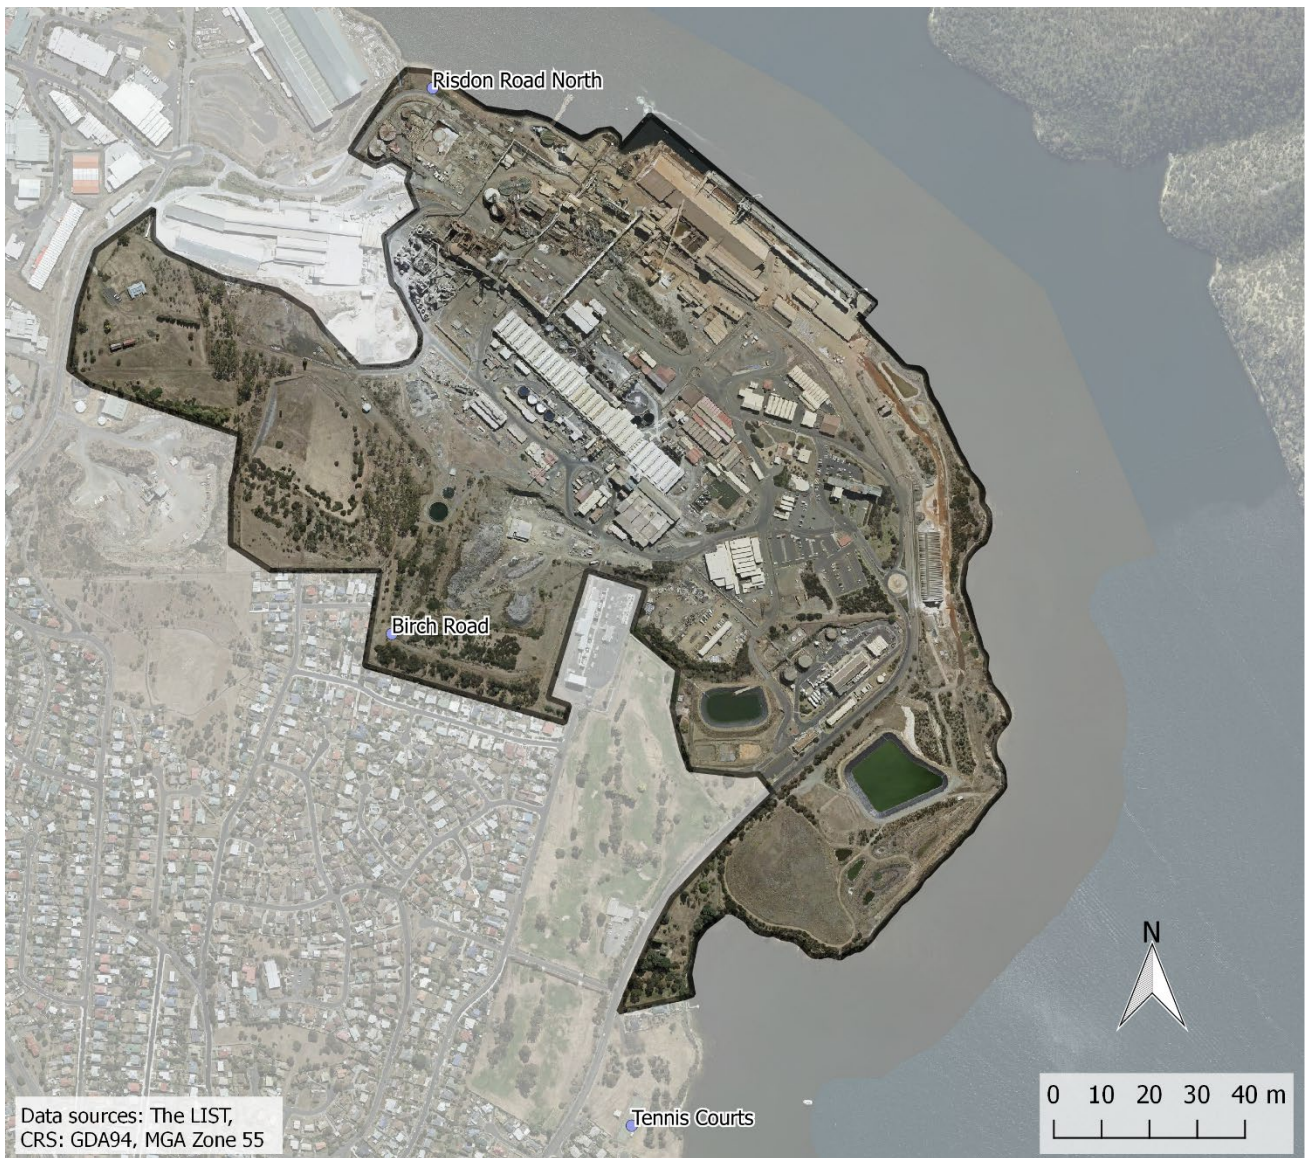
The sampling units collect 24 hour composite samples, operating continuously for a 24 hour period on a six day cycle. The units draw a large volume of air, approximately 70 m³/hr, using a vacuum pump, with airborne dust collected on a glass fibre filter paper. Filter papers are analysed for total particulate load and metals including lead, zinc, cadmium, iron and manganese. Average concentrations of dust and metals in air are calculated according to Australian Standard specifications using the HVAS operating hours, flow rate and particulate mass to give a result in micrograms per cubic metre (µg/m³).

Figure 4-7 Location of high volume TSPM sampling equipment

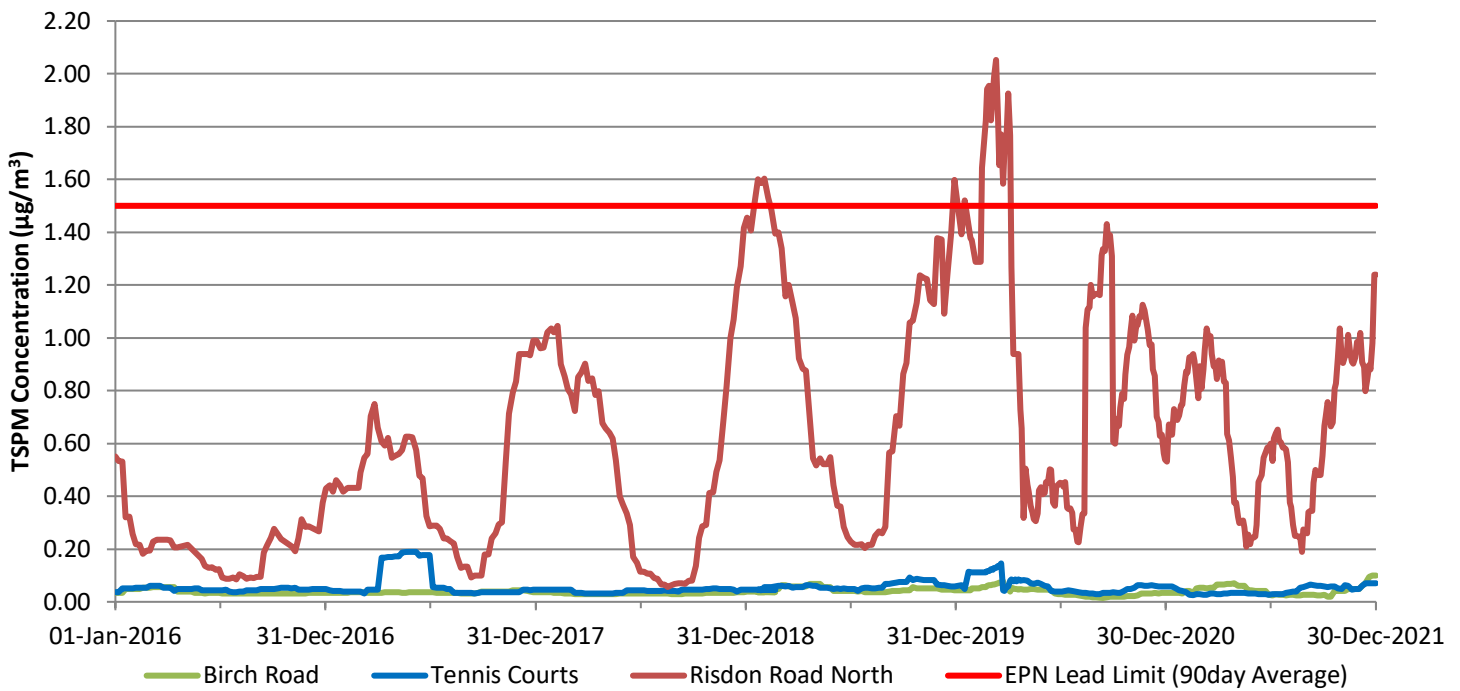
The 90 day rolling average for total suspended particulate matter of lead (TSPM-Pb) is the primary performance indicator for process dust emissions. The TSPM-Pb 90 day rolling average for the three sites between 2016 – 2021 are shown in Figure 4.9. The lead in TSPM results at Birch Road and the Tennis Courts were consistently well below the limit prescribed by EPN 7043/5. These findings are consistent with the previous 2016-2018 sampling period during which no non-compliances were recorded. The TSPM-Pb results at these two sites have typically shown a general downward trend in summer peak values since monitoring commenced in 2007.

Figure 4-9 90-day rolling average for TSPM-Pb across three monitoring sites compared to EPN lead Limit 2016 – 2021.

From late December 2019 to April 2020 there was a significant incident that resulted in elevated TSPM-Pb concentrations ranging from 1.5 µg/m³ to 2.1 µg/m³ at the RRN site. A detailed explanation of the incident has been reported in Appendix 2 – Notifiable and Reportable Environmental Incidents 2019 – 2021. Possible causes were linked to increased lead content of raw material during 2019-2020, ambient weather conditions and storage and handling practices. It should also be noted that due to the location of the sampling site, it is unlikely that this exceedance of the EPN has caused material environmental harm or nuisance to NH's surrounding community or environs.

Within the RRN TSPM-Pb results, seasonal trends are evident, with dust generally lower during the winter months. Again, this is consistent with the data recorded during the 2016-2018 sampling period.

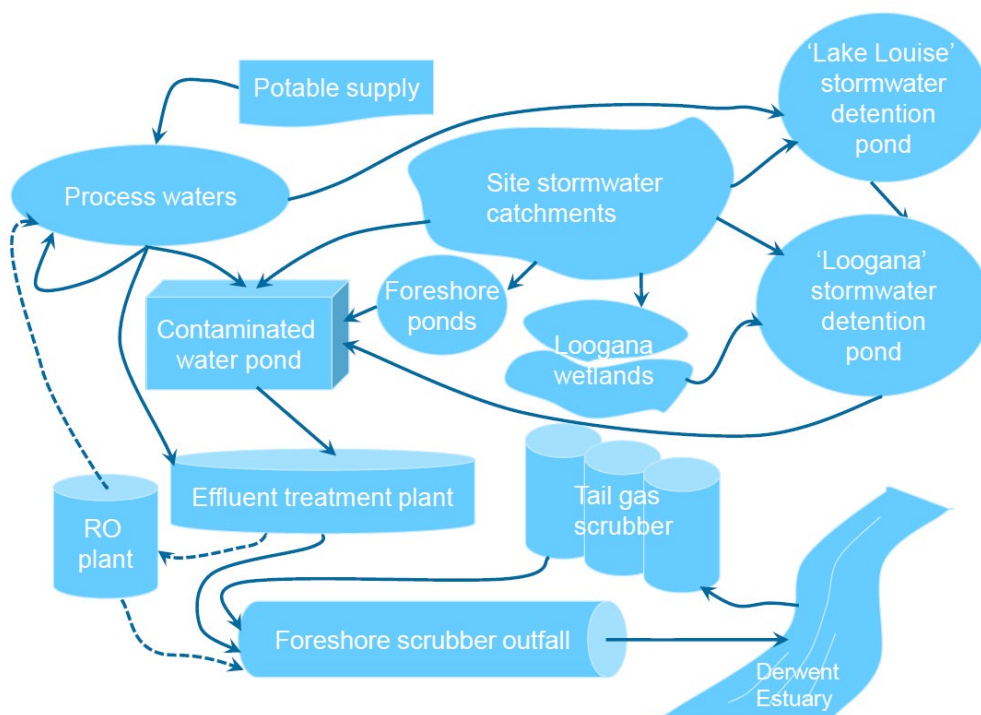
Figure 4-11 Process and stormwater system. Recycled water flows that came online in 2016 shown with a dotted line

Prior to discharge through the permitted outfall, flows from the ETP are combined with tail gas scrubber discharge (refer Figure 4.11).

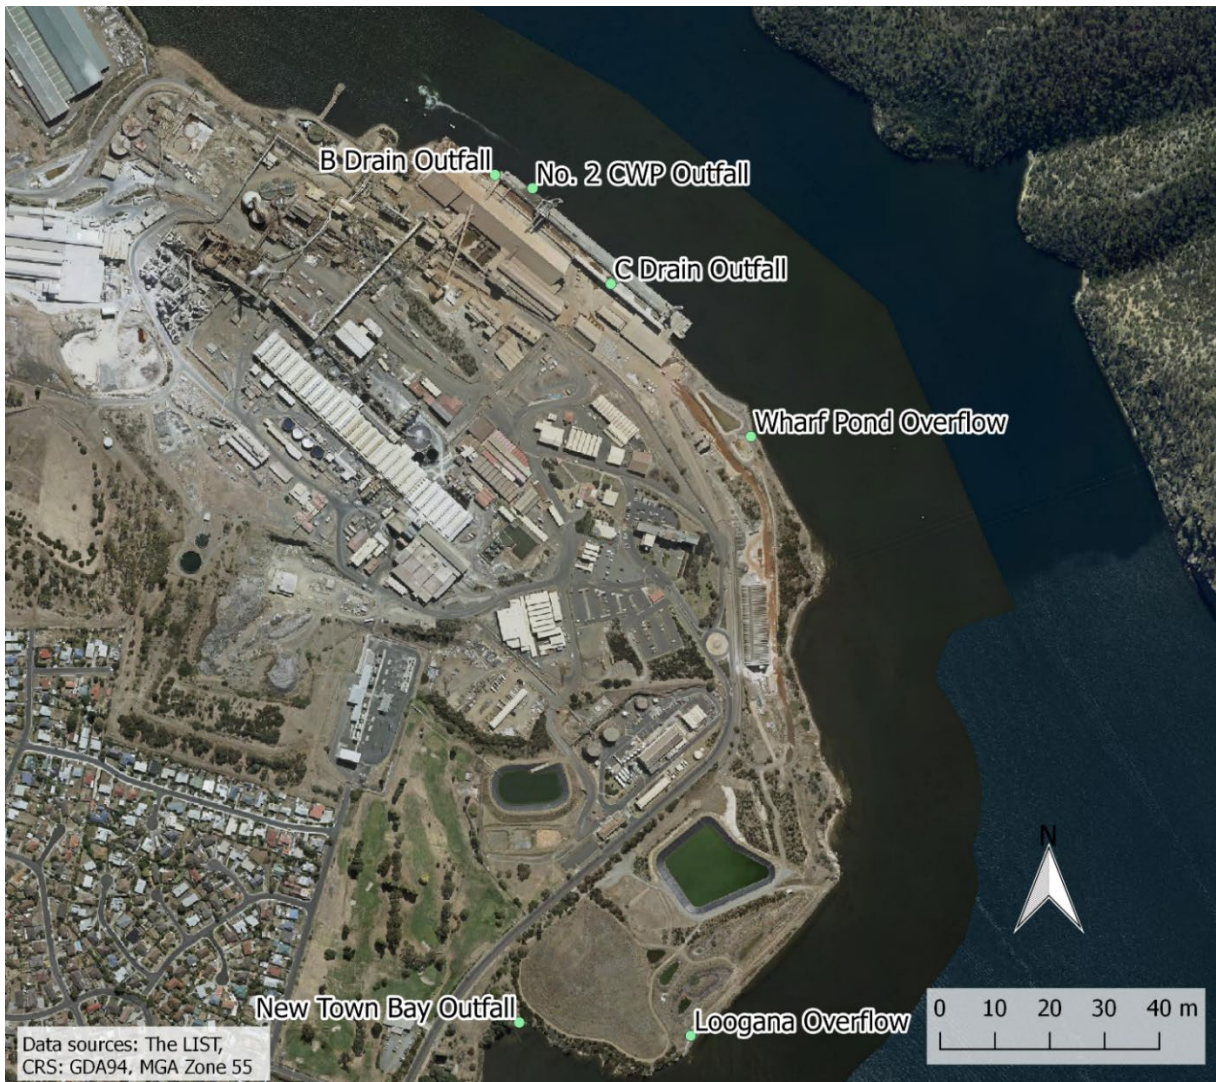
Figure 4-16 Surface water discharge monitoring locations – all points are emergency stormwater overflow points

Should such an overflow occur, sampling is conducted from any point at which discharge of stormwater occurs and is analysed by the NH laboratories. Stormwater incidents are reported to the EPA in accordance with EPN requirements.

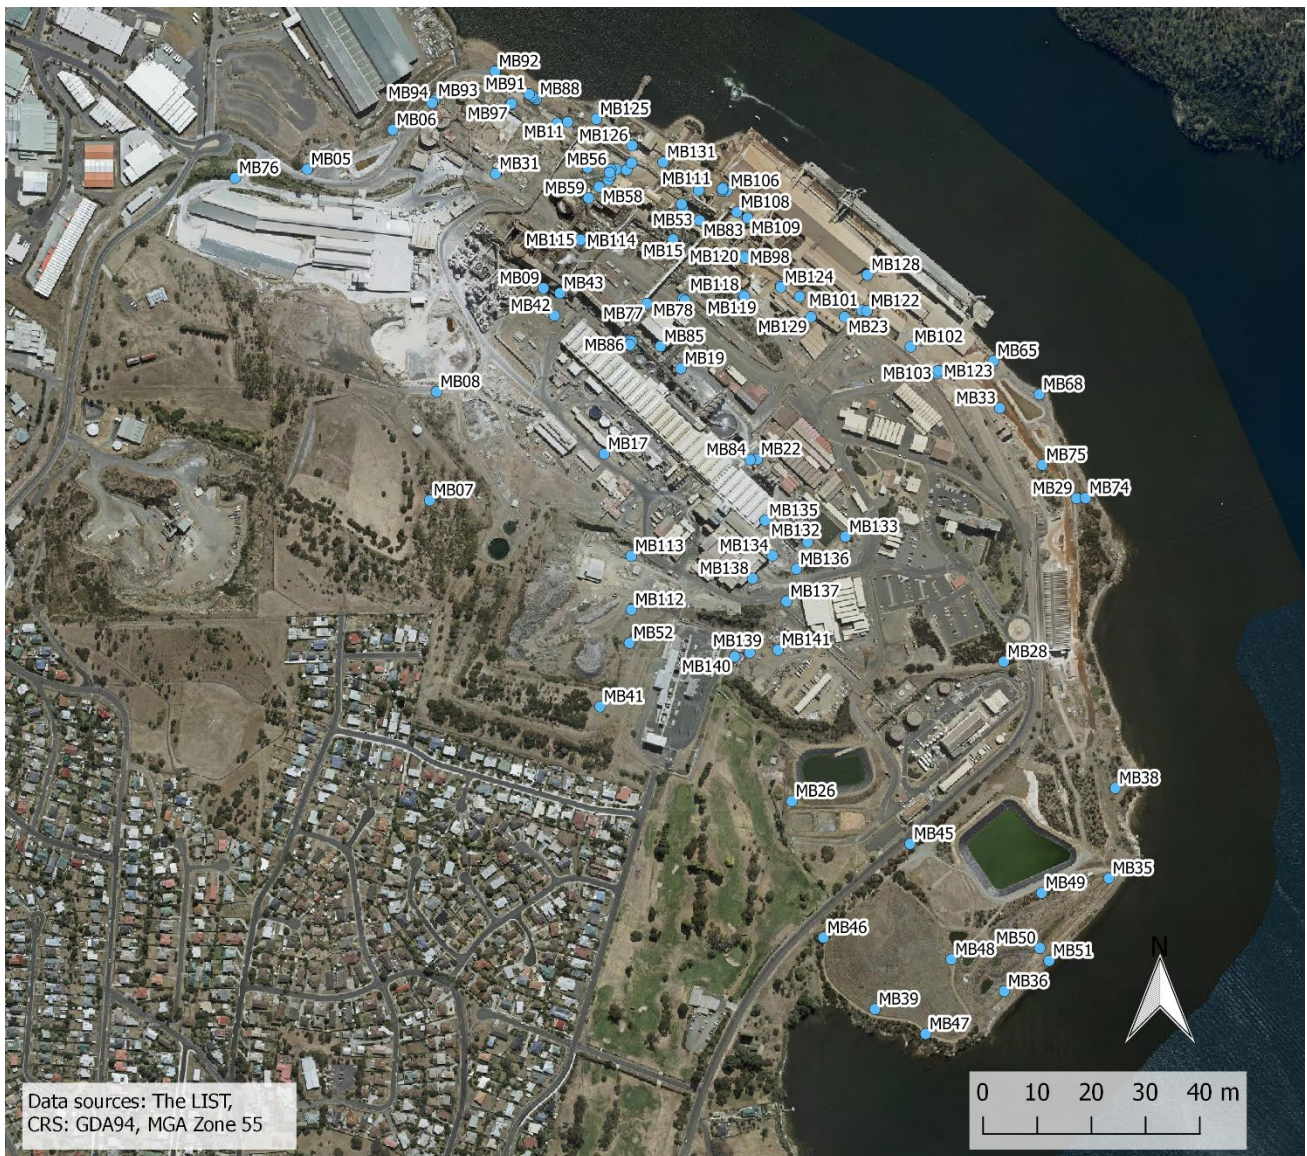
Figure 4-17 Groundwater monitoring borehole locations

The risk based method of determining sampling frequency has resulted in the following sampling program:

- High risk bores: 21 bores sampled in June and December each year.
- Medium risk bores: 41 bores sampled in November each year.
- Low risk bores: 44 bores sampled in November every second year (2017, 2019 etc.).

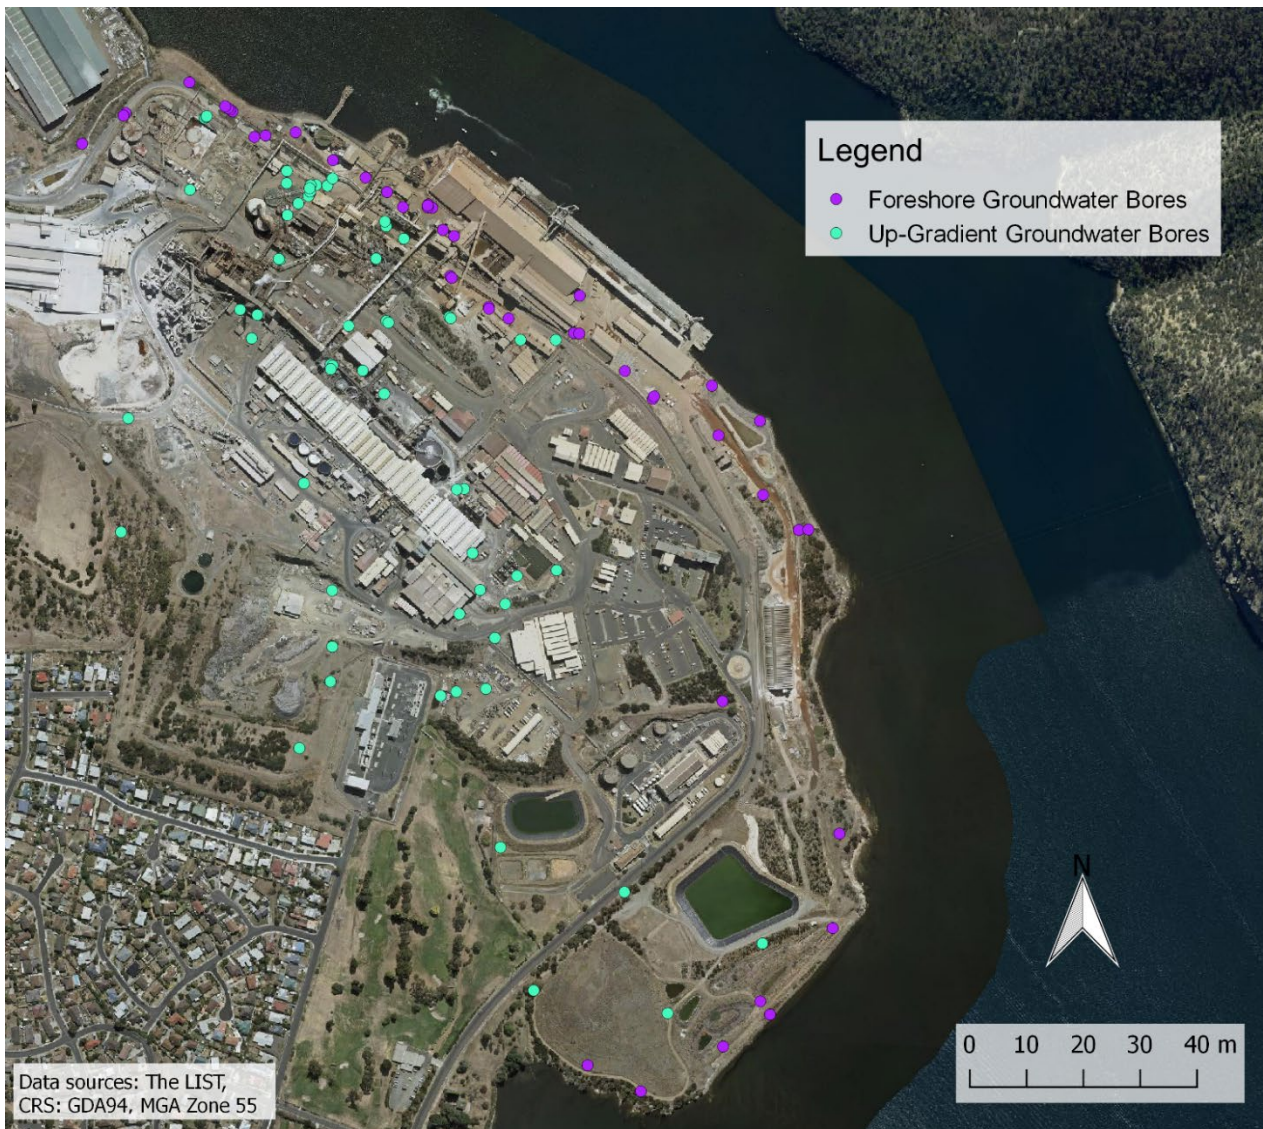
Figure 4-26 Groundwater monitoring bore locations, upgradient vs foreshore.

Comparison of the two datasets can be used to compare and contrast the distribution of contaminant concentrations within groundwater between; onsite bores situated in operational areas - where contaminants are expected to be higher, against peripheral, down gradient bores along the Site's boundary.

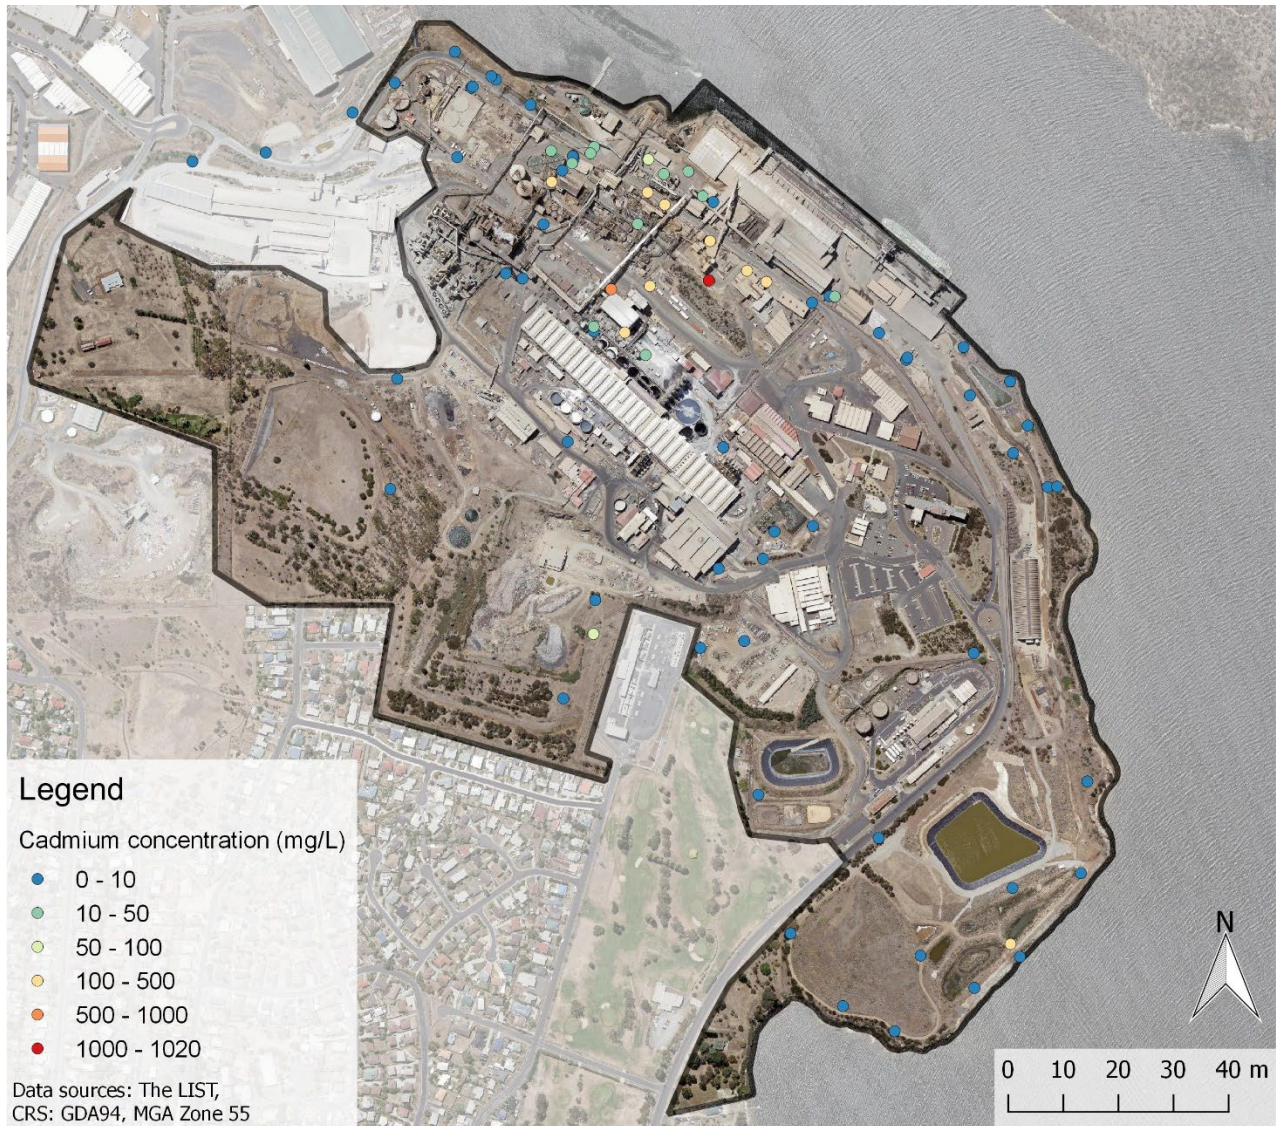
The cadmium concentrations measured in the site's monitoring bores (Figure 4.30) is consistent with previous reporting periods, identifying the main hotspots to be in the area of the Old Leach Plant, and the current Cadmium Plant.

Figure 4-30 Cadmium (mg/L) in groundwater beneath the NH site from 2021 groundwater monitoring data

Within the following pages, several figures have been prepared indicating the concentration of individual metal contaminants within groundwater across the site. The data originates from groundwater samples collected during the Q4 2021 sampling event where all available and accessible groundwater bores were sampled at the time.

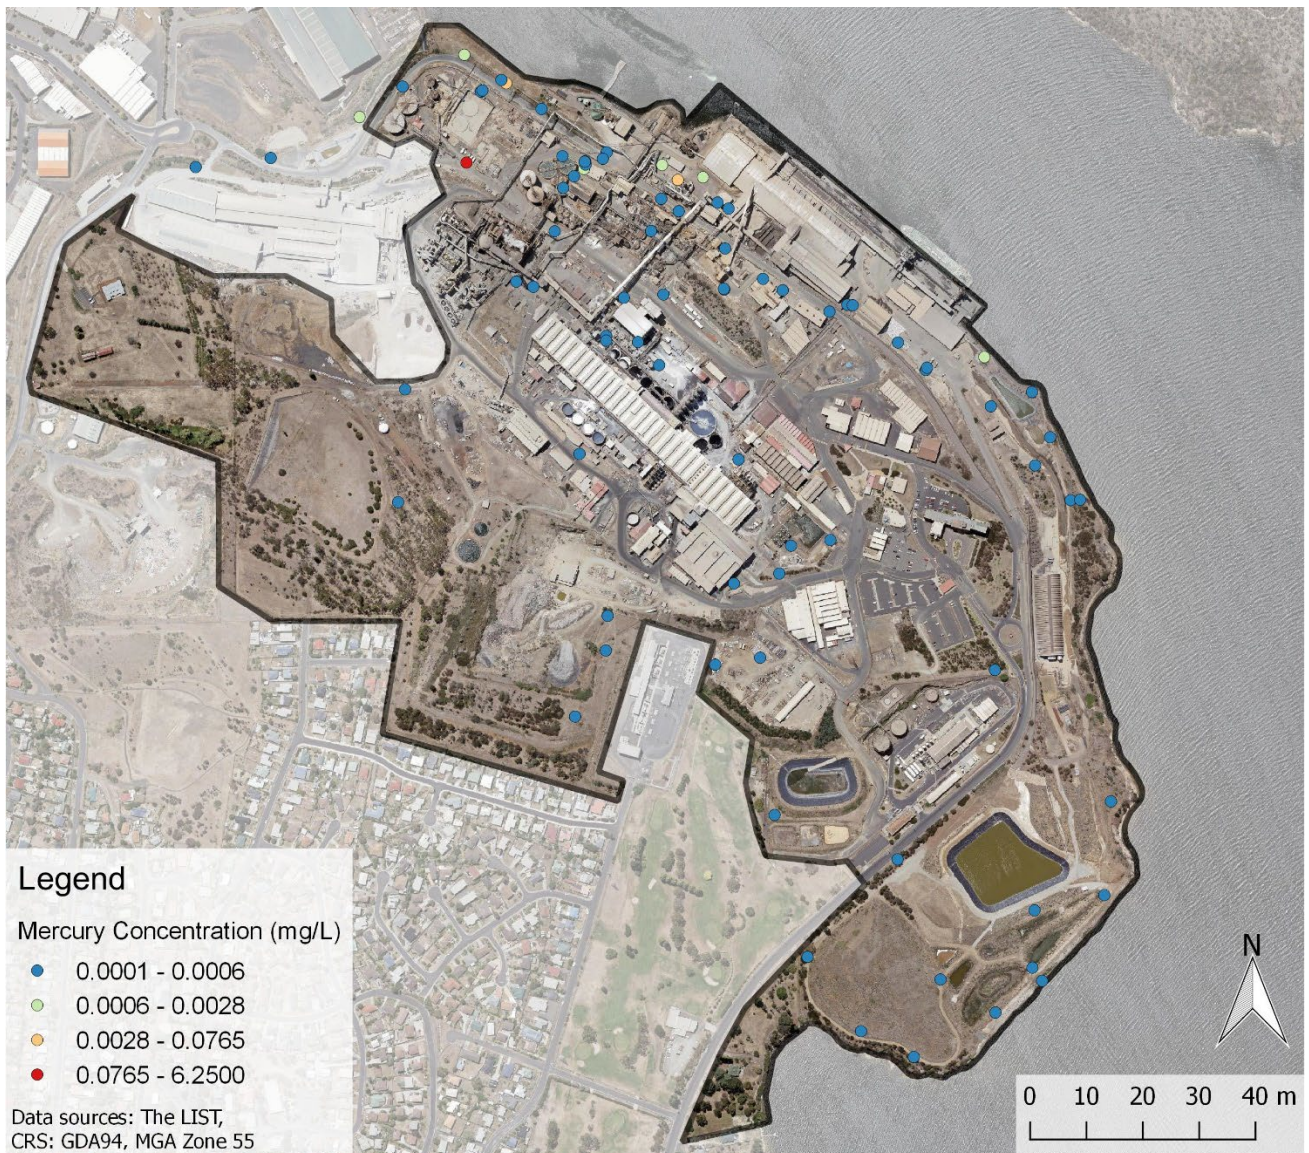
The distribution of mercury within groundwater across the site is presented within Figure 4.31. The area displaying the highest concentrations of mercury is downgradient of the acid plants, where mercury liquors are stored as part of the process. The results are consistent with previous years.

Figure 4-31 Mercury (mg/L) in groundwater beneath the NH site from 2021 groundwater monitoring data

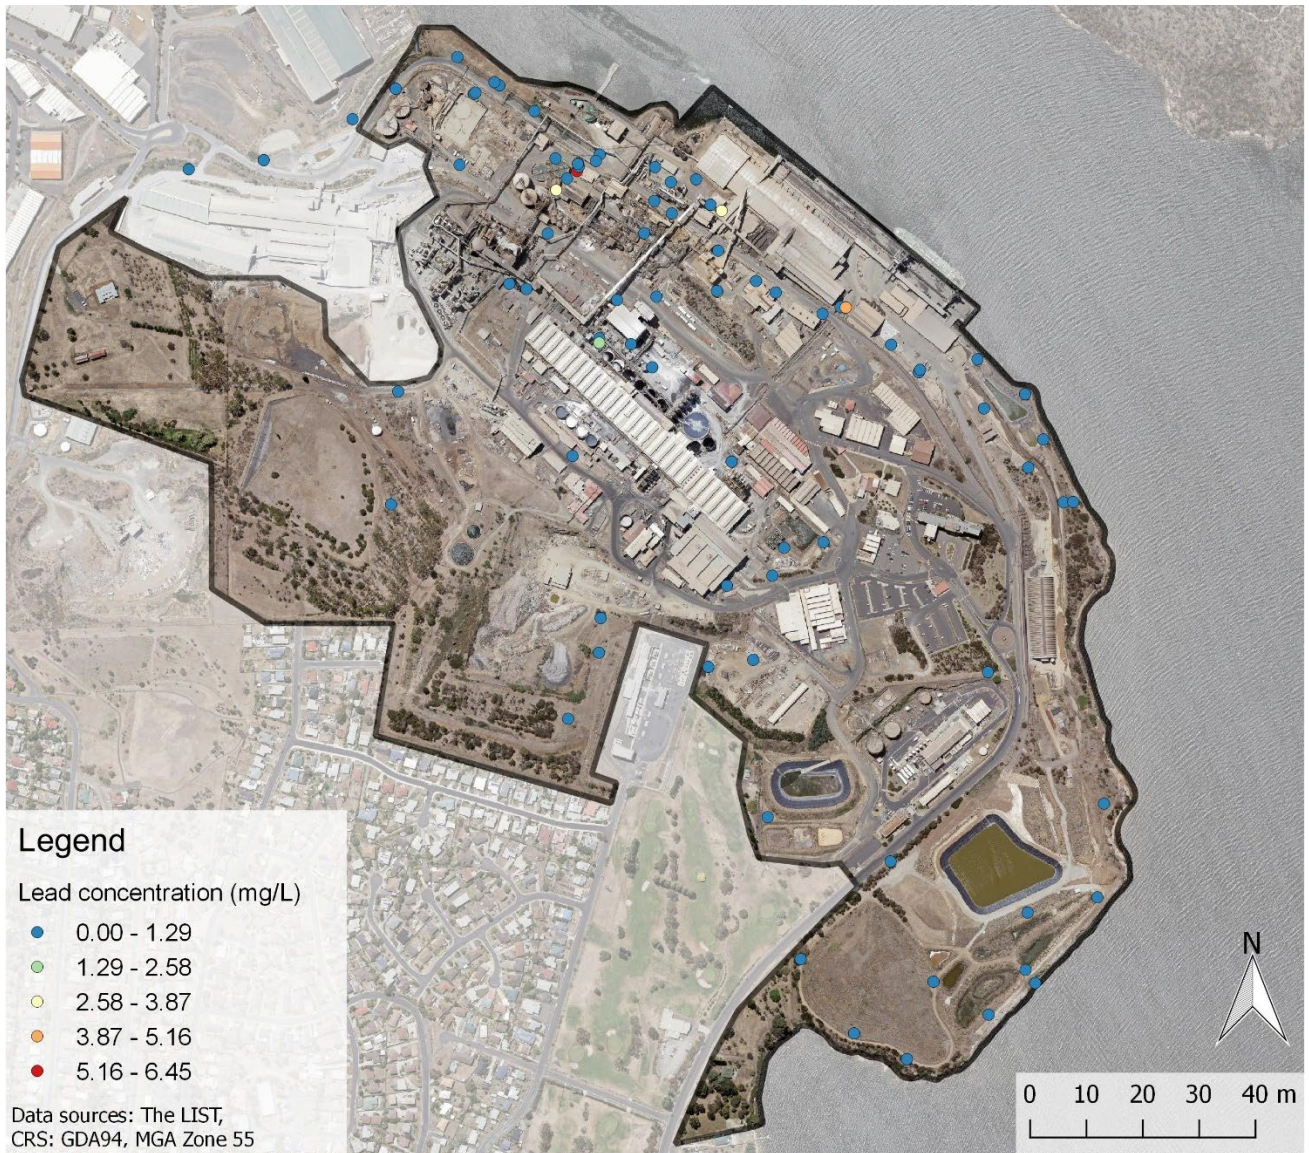
The concentration of lead within groundwater during the 2021 monitoring year is provided within Figure 4.32. Concentrations are greatest within areas down hydrogeological gradient of the Leach department, where lead is removed from the hydrometallurgical circuit.

Figure 4-32 Lead (mg/L) in groundwater beneath the NH site from 2021 groundwater monitoring data

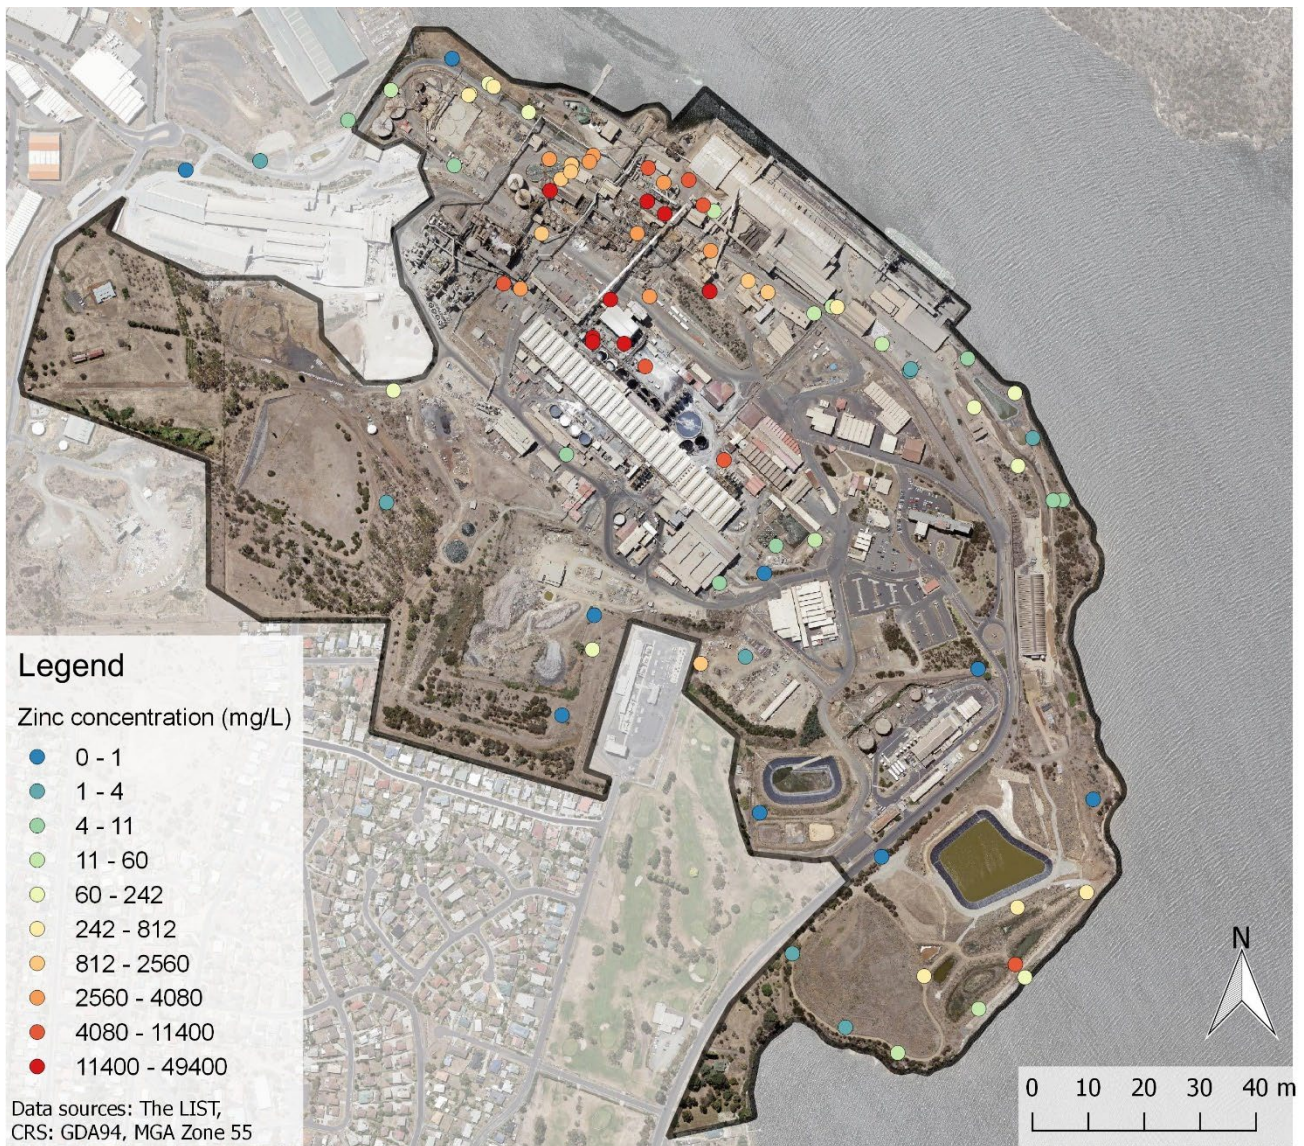
The mapped concentration of zinc within groundwater (refer Figure 4.33) identifies the most contaminated areas to be those within the Purification and Leach Departments, which are located down hydrogeological gradient of the Cellhouse. This is consistent with previous year's results.

Figure 4-33 Zinc (mg/L) in groundwater beneath the NH site from 2021 groundwater monitoring data

In general, the mapped concentrations clearly show that the most significant areas of contamination are located downgradient of the Electrolysis Department. This entire area is subject to groundwater extraction, whereby large volumes of contaminated groundwater is pumped to the onsite Effluent Treatment Plant, which recovers the metal from groundwater. Each of the groundwater extraction systems are described within the following pages.

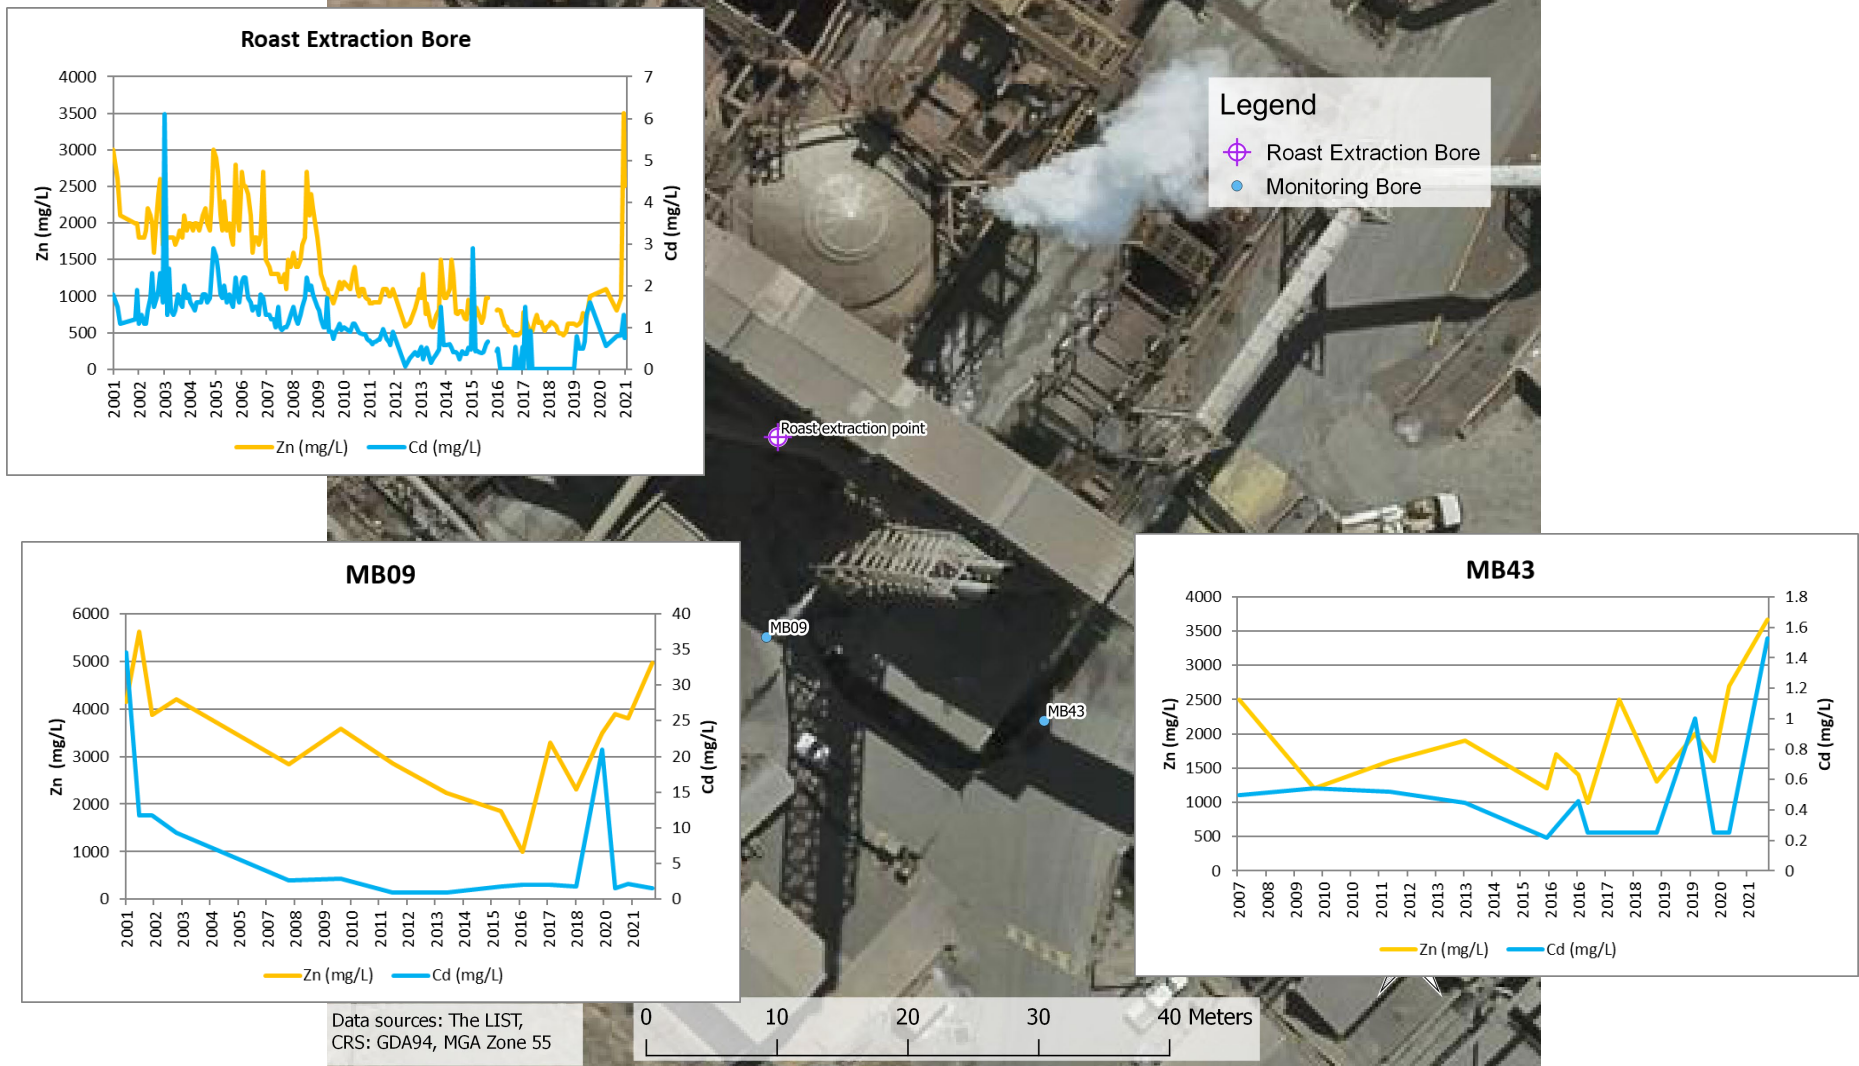
Metal concentrations within the Roast Extraction Bore have generally declined since 2001, as shown in the graphs on the following page. Data collected over the reporting period indicates that the concentration of both zinc and cadmium within the area of the Roast Extraction Bore have increased. This may be due to the sub-optimal performance of the pump within the well, resulting in poor flows.

Figure 4-36 Metal concentrations in the Roast extraction bore and associated monitoring bores
