Nyrstar Hobart Triennial Public Environment Report 2019 – 2021

VERSION 2: SUBMITTED 13 MAY 2022

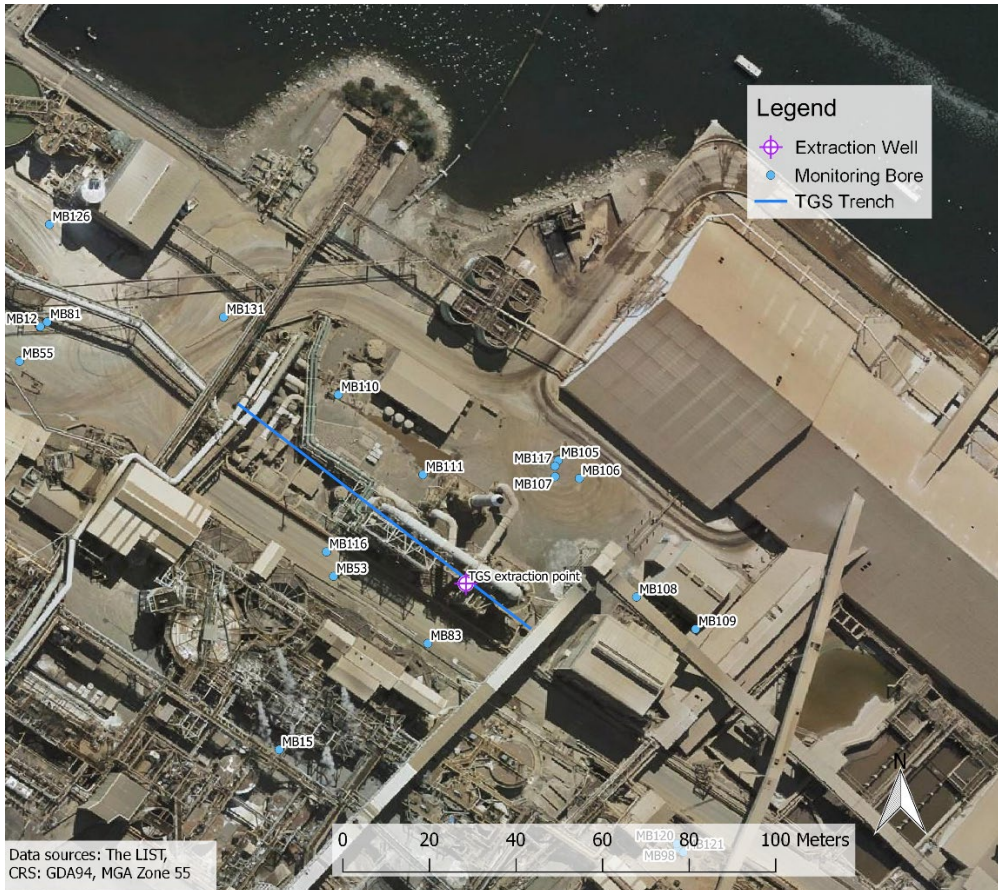
The Tail Gas Scrubber extraction system comprises of a trench approximately 80 m long excavated typically 1-2 m below ground surface. A drainage pipe lies at the base, surrounded with coarse gravelly fill. A sump approximately 2.5 m in depth acts as a collection point for groundwater extraction. The system, that was commissioned in 2001 targets the unconfined aquifer onsite, as the collection trench largely site within poorly consolidated sediments or fill over the underlying dolerite.

Figure 4-42 Location of Tail Gas Scrubber Trench Extraction System

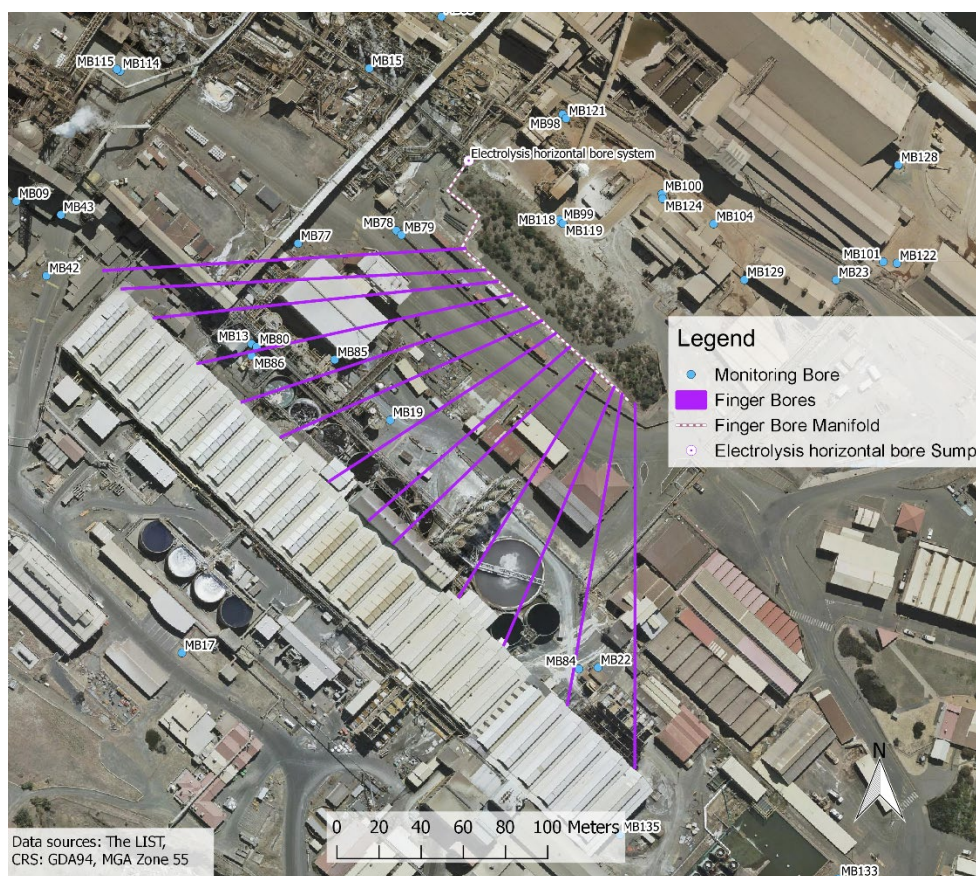
In 2008, 13 horizontal bores were drilled with an inclination of approximately 0.7 degrees from the horizontal in a fan-like manner extending from the historical leaching section of the Site towards the operational Electrolysis Department. The layout of these bores is included within Figure 4.44 below. Each of the bores are connected via a manifold to a common drain and flows via gravity to the site contaminated water system.

Figure 4-44 Location of Electrolysis Finger Bores

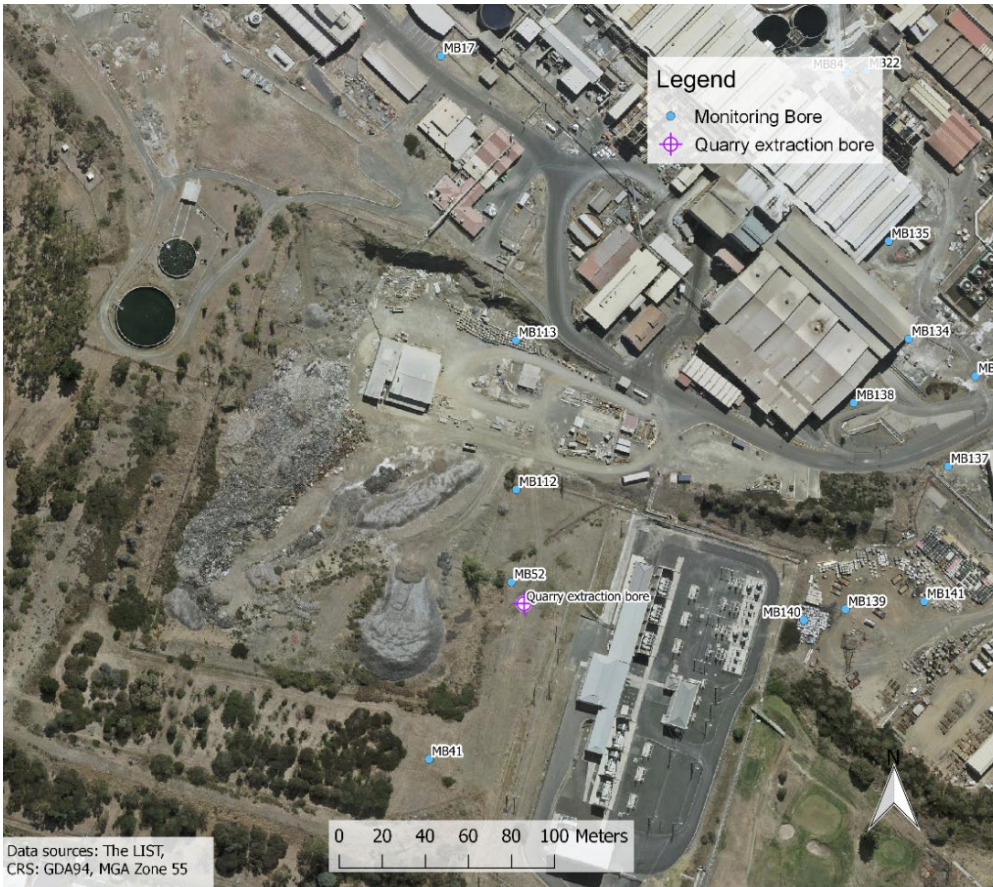
The Quarry Vertical Extraction Bore was installed in 2010 to a total depth of 28.6 m below ground surface. The bore is located down hydraulic gradient of a historical dolerite quarry that has been used as a storage repository for contaminated soil and contaminated timber, resulting from various demolition projects that have occurred at the site.

Figure 4-46 Location of the Quarry Vertical Extraction Bore

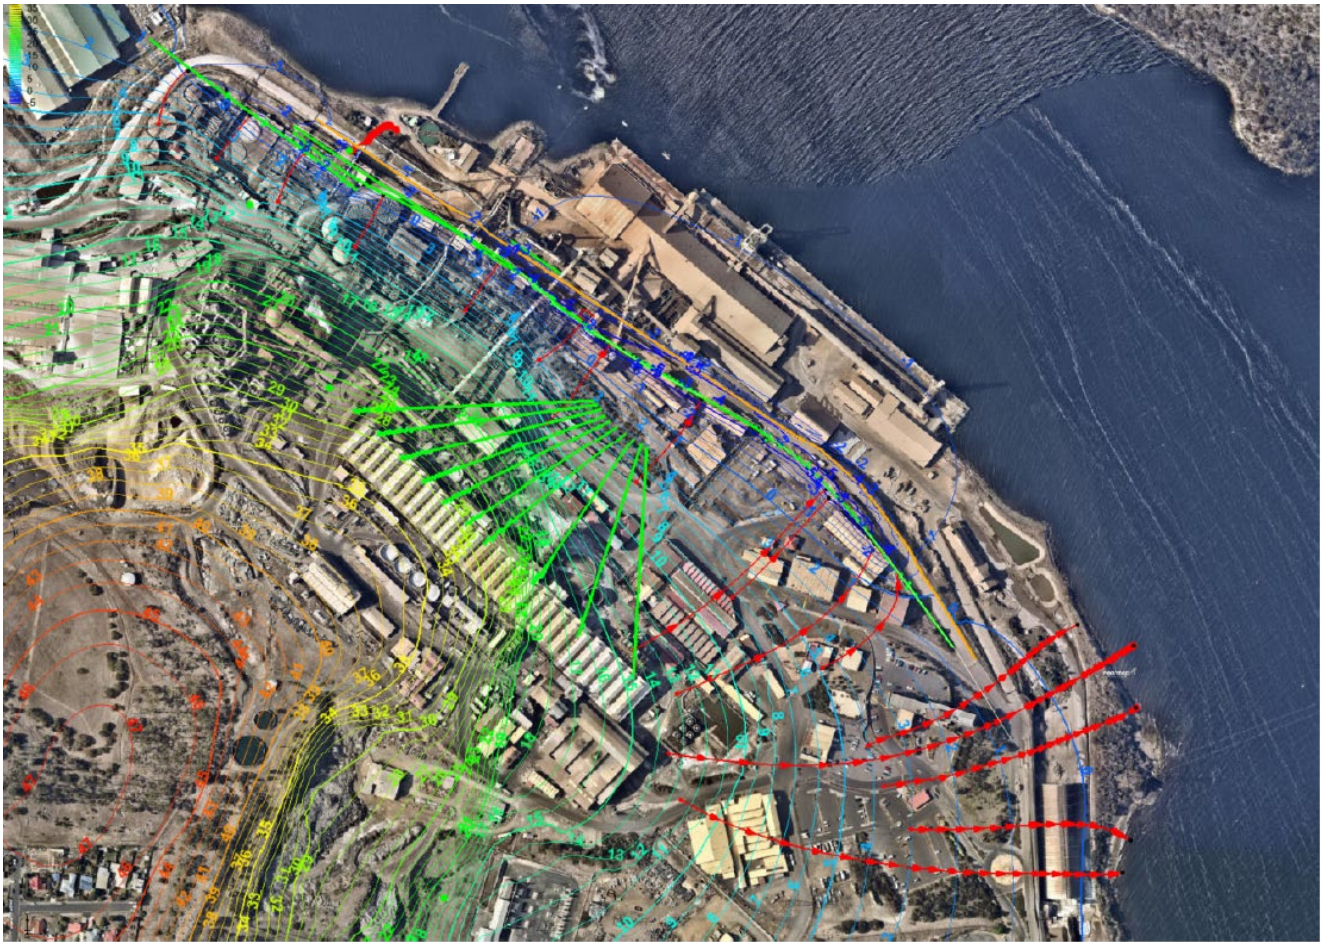
The modelled capture zone of the PG Dryer extraction system/EB05 is presented in Figure 4.51. Groundwater flow paths are represented as red lines, while groundwater collection drains are presented as thick green lines.

Figure 4-51 Modelled groundwater flow for the central and southern section of the site with the new grout curtain and horizontal drain in place

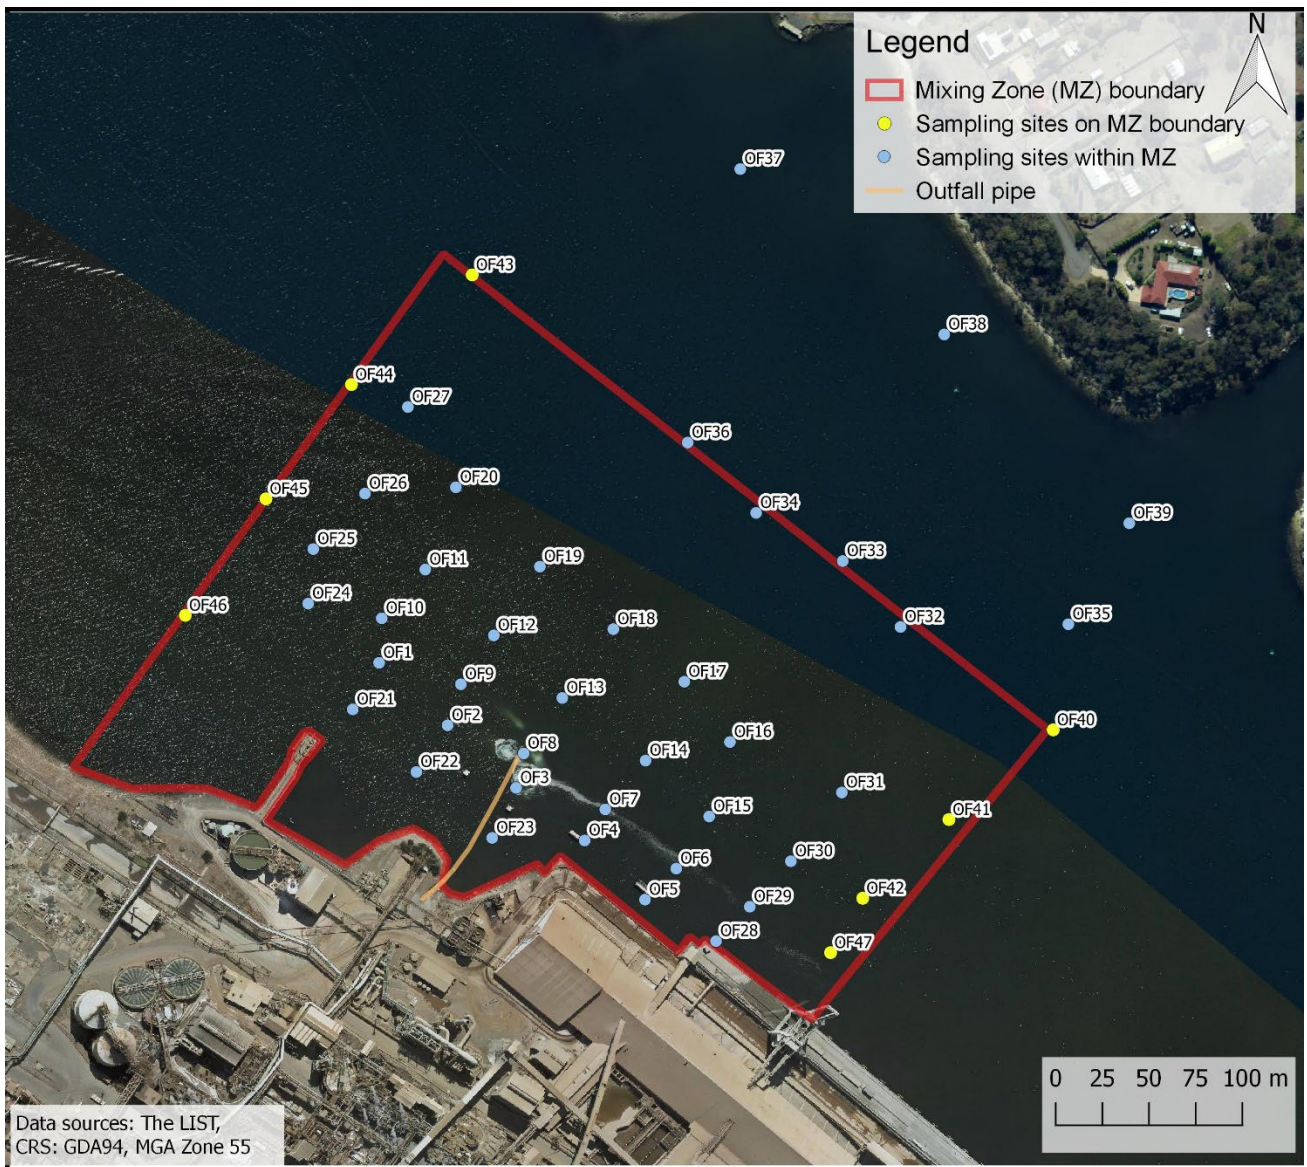
To assess the impact of the point source discharge from the site, NH maintains a mixing zone sampling program around the permitted discharge point at the foreshore outfall (Figure 4.52). The aim of this program is to confirm that sufficient dilution of effluent has occurred within the mixing zone in order to meet Tasmanian State Water Quality Objectives at the boundary of that zone. Sampling sites within the mixing zone were used to define the mixing zone in 2001.

Figure 4-52 Point source mixing zone boundary

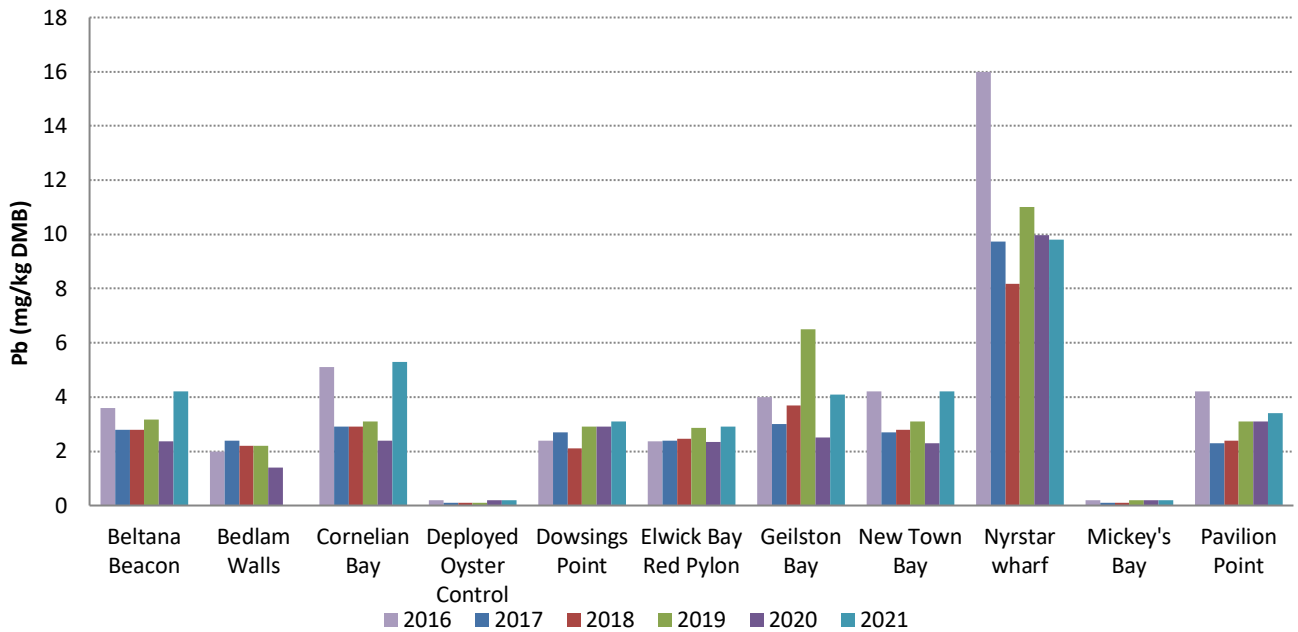
Figure 4-65 Lead concentration in oyster deployments 2016–2021

Figure 4.62 to Figure 4.66 show the accumulation of zinc, mercury, cadmium, lead and copper over the exposure period from the baseline level (deployed oyster control site). No oysters were collected in the 2021 deployment from the Bedlam Walls site as the oyster cage was reported missing. For the reporting period, the data indicates that concentrations of zinc, copper and cadmium increased throughout the estuary in 2019 compared to previous years, then proceeded to decline in 2020 and increase again in 2021. As there was no noticeable site operations or rainfall conditions at the time, these results demonstrate the high variability of the Derwent River and continues to support the concept that the broader estuarine environmental conditions play a strong role in uptake rates. The DEP⁷ also notes the unexplained increase in zinc concentrations in 2019 compared to 2018 data. There was a noticeable decrease in zinc concentrations in oysters deployed across the estuary in 2020 with the exception of Mickey's Bay. Despite the noticeable decrease in zinc, copper and cadmium concentrations in 2020, the increase in these concentrations in 2021 as well as the increase in lead concentration demonstrate the variability and requirement for close monitoring.

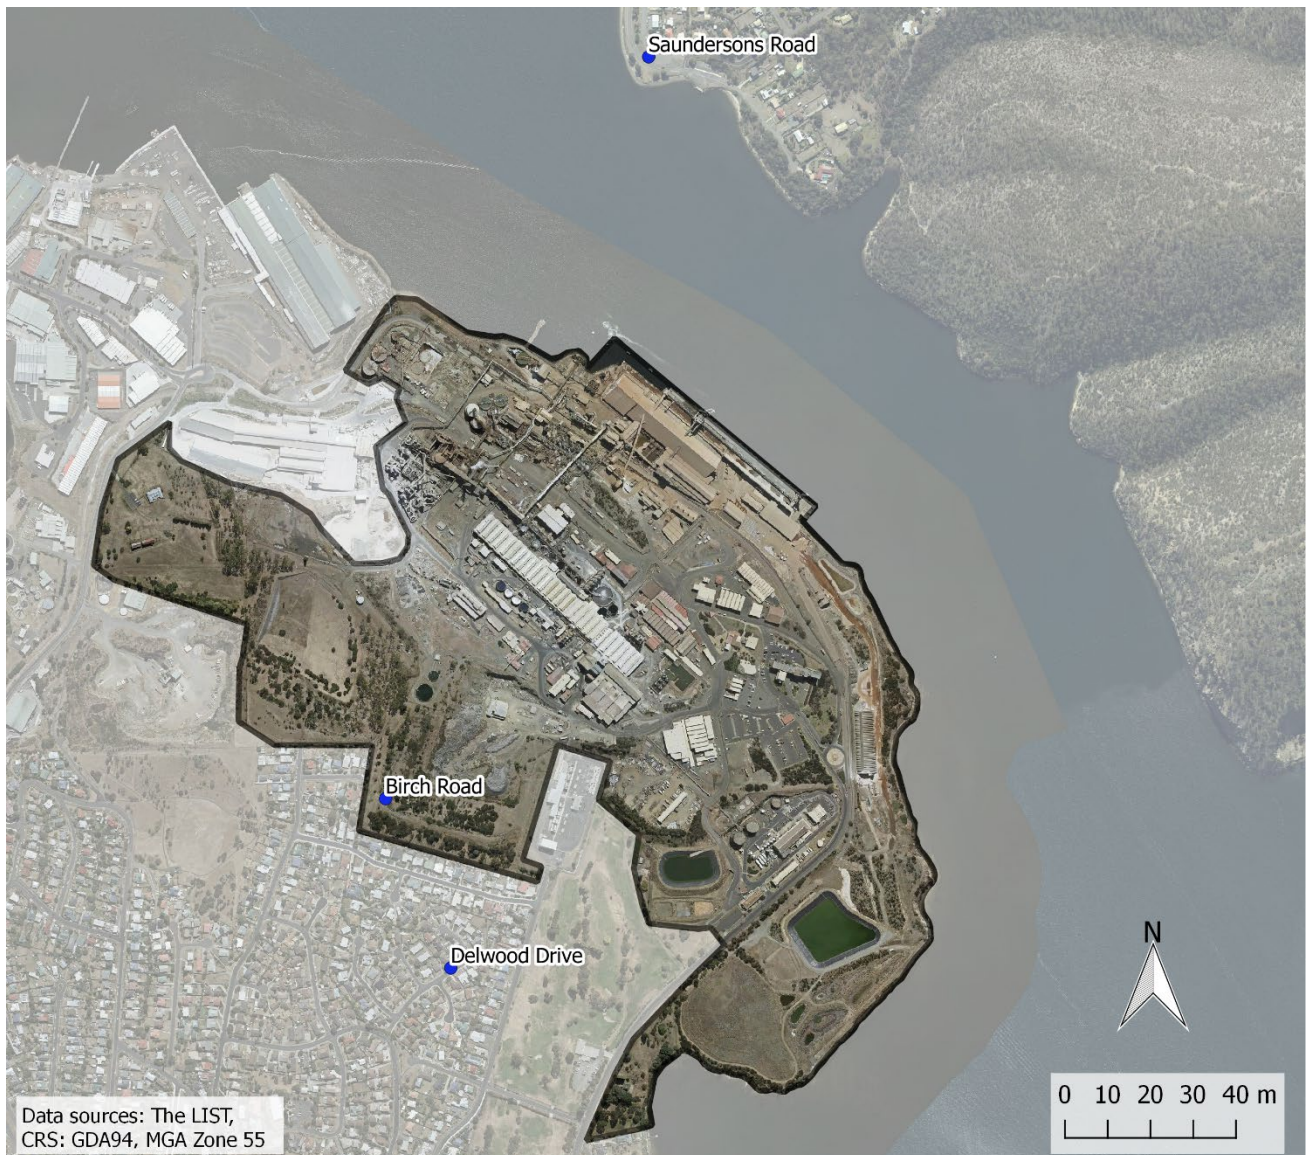
Figure 4-79 Noise monitoring locations

NH monitors noise continuously at three stations within the neighbouring community. The stations are located in Birch Road and Delwood Drive, Lutana and at Saundersons Road, East Risdon (Figure 4.79).

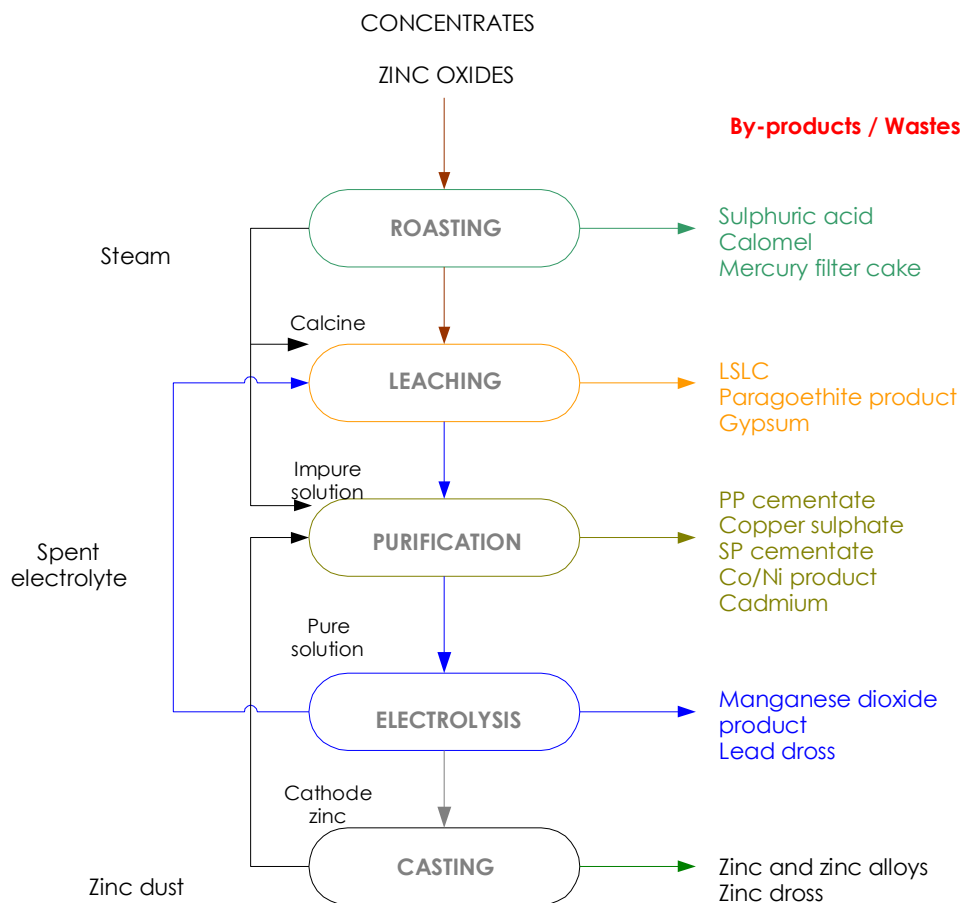
Figure 4-81 By-product flow sheet

The production process at NH uses raw materials (concentrates), which contain zinc as well as other metals and sulphide. Metals do not degrade so the principle of 'mass balance' applies to the smelting process whereby all metals entrained in concentrates will present as a residue or by-product. Figure 4.81 shows a schematic of the NH process flow sheet highlighting key by-products and wastes that are generated as part of zinc production. Materials are removed from the process as either products for direct sale, by-products for potential reuse and / or sale, or process wastes requiring disposal. Some stockpiled waste residues that are no longer produced are still present on NH land as described in the following sections.

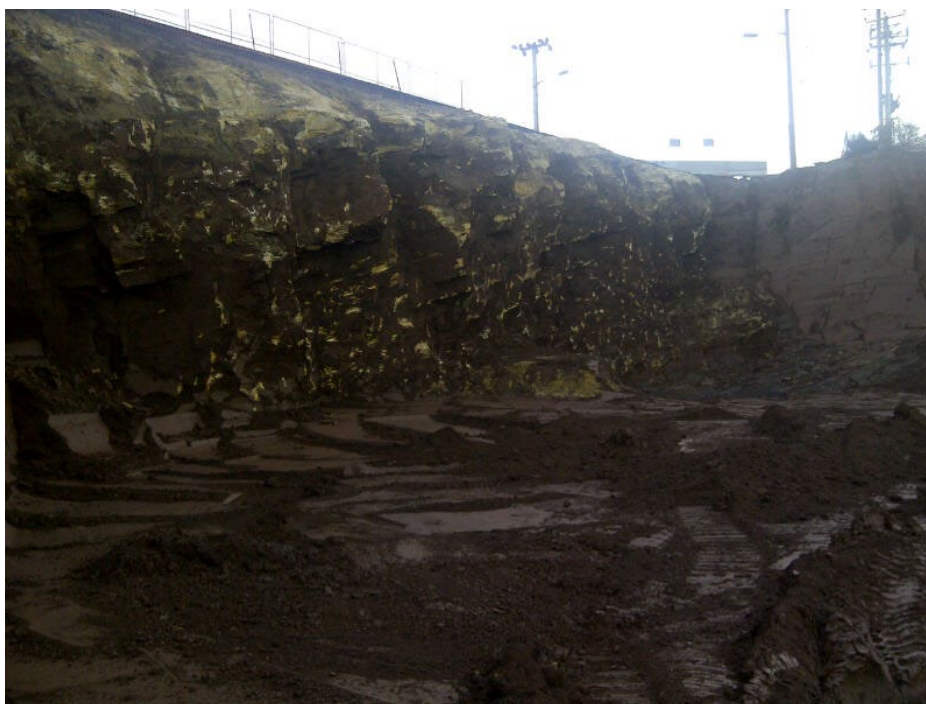
Figure 4-82 Remaining HLP1, shown on far right

HLP1 is no longer produced at NH, though two known areas of HLP1 material remain in the Loogana precinct after the 2013 removal project. These are in close proximity to TasNetworks power infrastructure adjacent to the 2014 rehabilitation area (Figure 4.82), and in a section of the foreshore at Woodman's Point. During rehabilitation works, the material near the TasNetworks infrastructure was delineated with geofabric between the HLP and the rehabilitated area. The parcel at Woodman's Point was found during exploratory potholing on the foreshore embankment and further investigative work will be required to define the product boundaries. Recovery and rehabilitation in this area is challenged by the proximity of the material to indigenous midden artefacts.

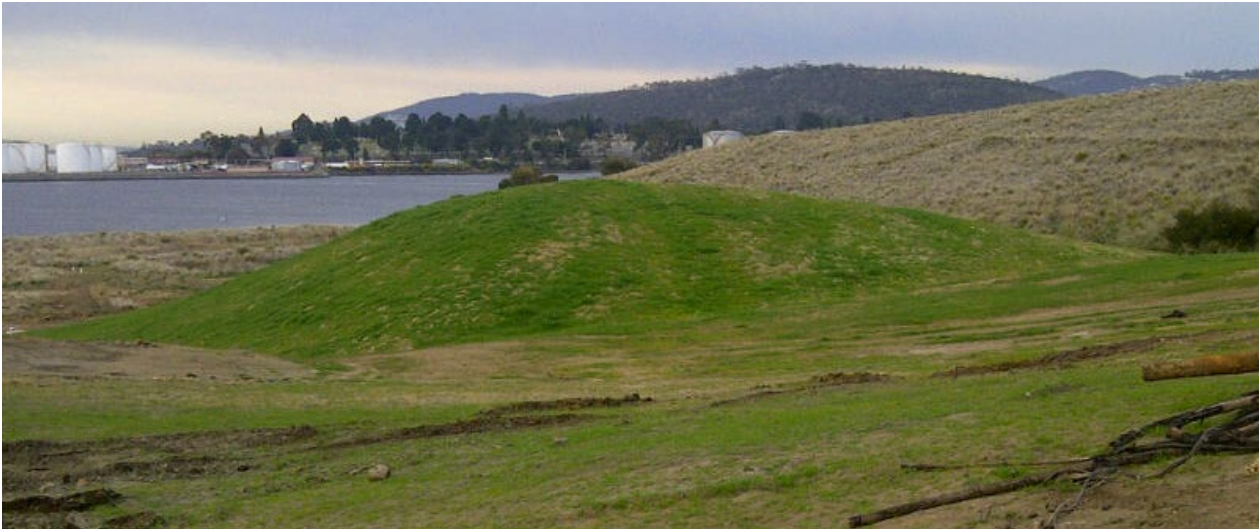
Figure 4-83 Jarosite secure landfill

The temporary secure landfill cells for jarosite (Figure 4.83 and Figure 4.84) are monitored so as to ensure that no environmental harm results from the temporary stockpiling of the material. The monitoring results from the Loogana–Inshallah area continue to indicate that the original jarosite landfill performance is satisfactory with no leakage detected.

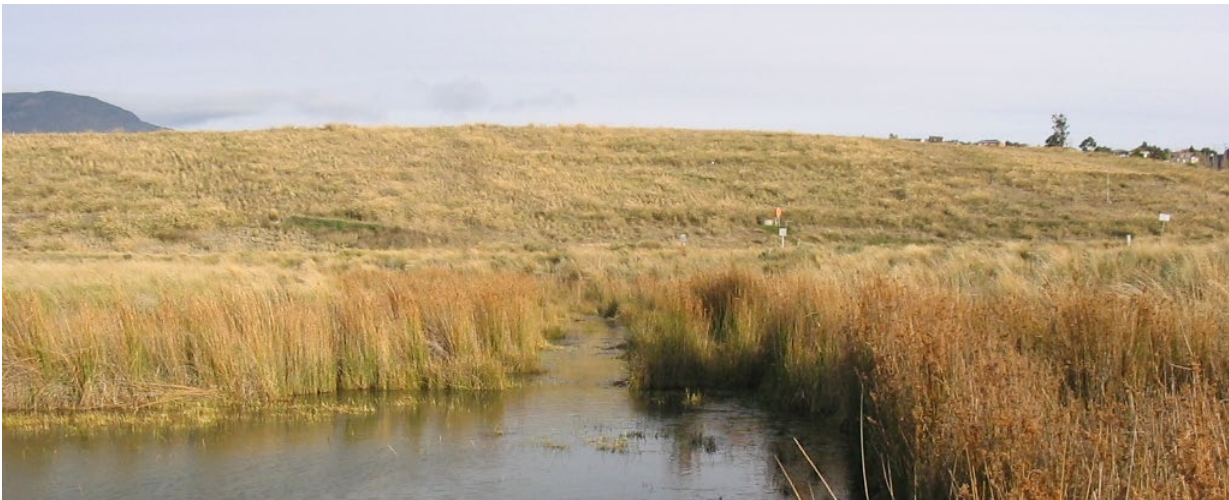
Figure 4-84 Jarosite secure landfill

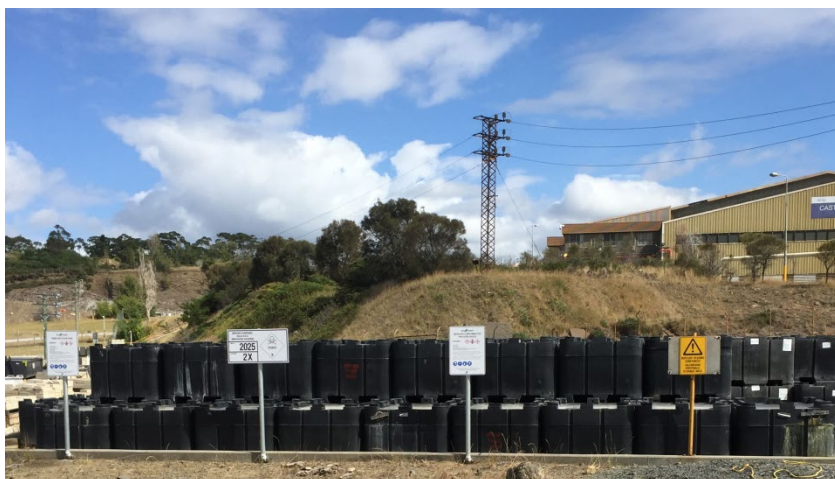
Figure 4-85 Purpose built containers containing Mercury Filter Cake, pre-treatment

In early 2020, approximately 25 t of MFC was sent to a mercury recycling plant in Melbourne, in order to trial the transport and recycling of the material. The transport of the MFC proved to be extremely challenging, due to the classification of the material as a Dangerous Good, and the limitations of the containers in which the material is stored.

In 2021, laboratory trials were successful in combining MFC with magnesium oxide (MGO) to successfully treat the material for disposal as a level 3 contaminated soil under IB105 classification. In April and June NH disposed of a total of approximately 128 t of treated MFC to the Copping C Cell. NH plans to continue treating and disposing of the stockpiled waste whilst continuously investigating various treatment options.

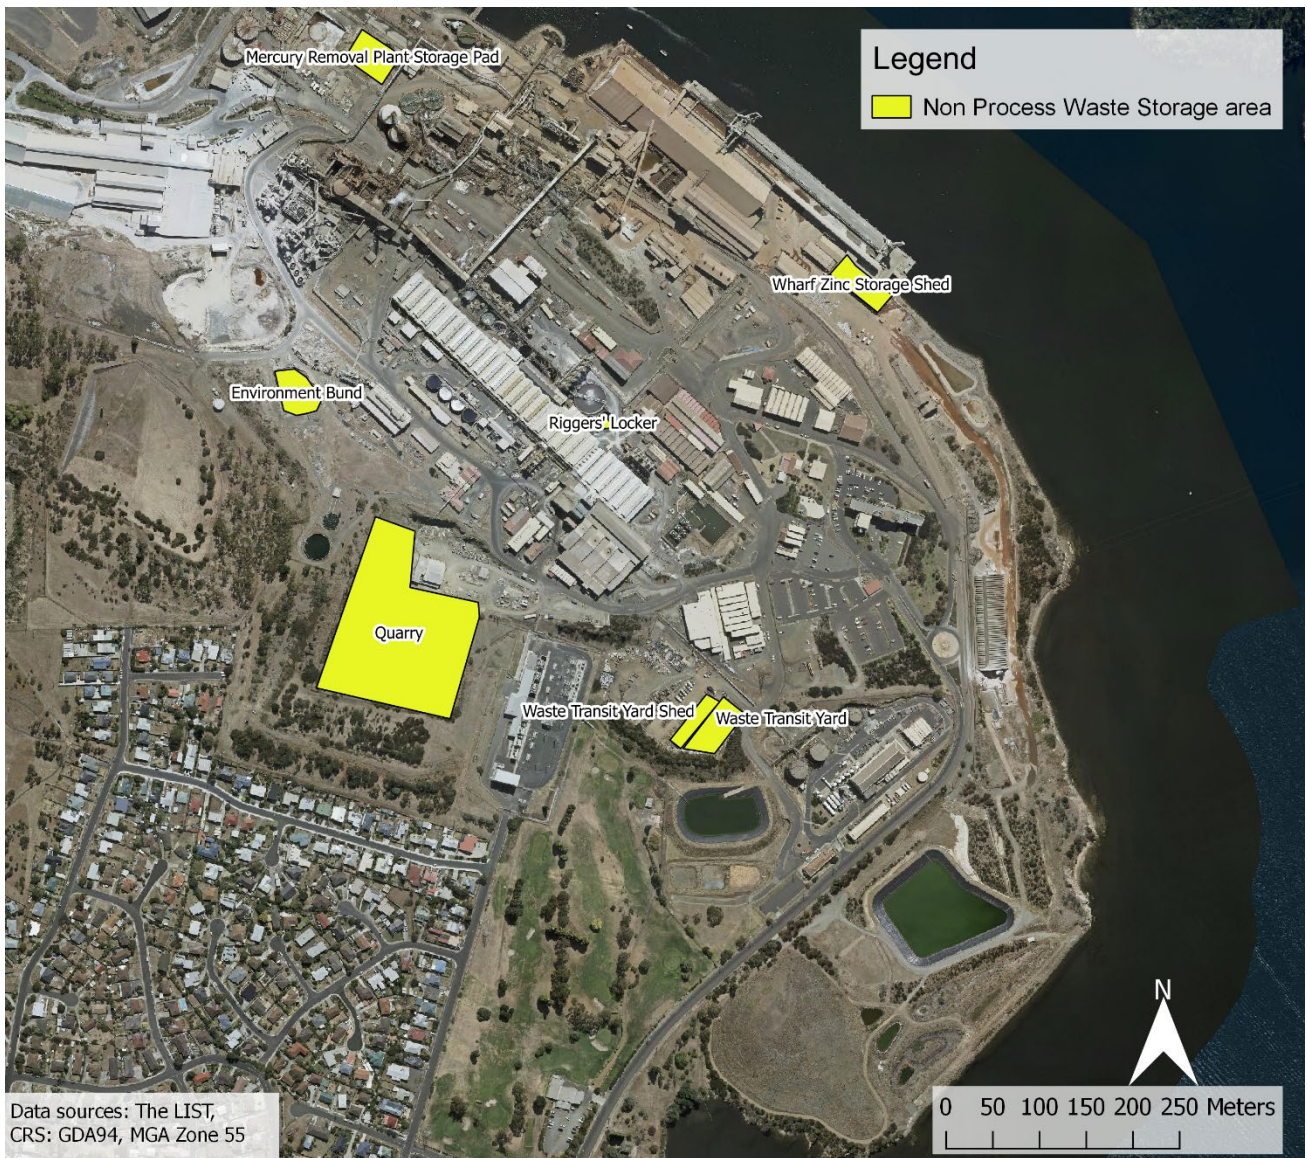
Figure 4-89 Non-process waste storage locations

An inventory of stockpiles of process and non-process waste remaining on the site is shown in Table 4-18, and a map of all of the non-process waste storage locations is shown in Figure 4.89.

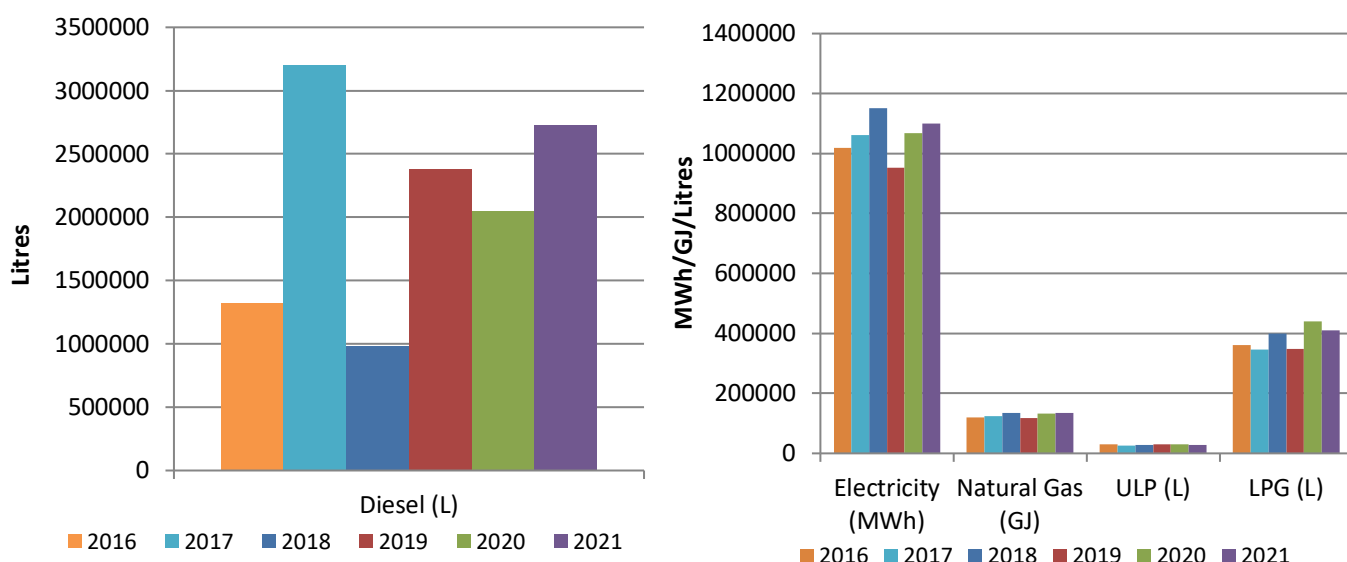
Figure 4-90 2016 – 2021 energy consumption

NH tracks energy consumption on a monthly basis. Annual consumption for the current, and previous reporting period is shown below in Figure 4.90. Diesel consumption has been included as a separate graph for optimal data display.

With the exception of diesel, energy consumption has remained reasonably stable over the current reporting period. The bulk of the diesel consumption on site is a result of significant shutdown events. The roasting process generates a significant volume of steam which is used to power other parts of the plant. When the roasters are not operating, as is the case during shutdowns, the steam must be produced using diesel fuelled package boilers. In addition, it requires a significant amount of diesel to start up the roasters after a shutdown. Even with the shutdown, the energy content of the waste heat recovery (in the form of steam) equates to approximately 616,000 GJ per year. This equates to almost five times the energy consumed in the form of natural gas for the year, and thus represents a significant energy recovery program.
